Advanced Home Inspections

Property Inspection Report

3256 Sample Rd, Sulphur, LA 70665
Inspection prepared for: Client Test 1 Story Template
Date of Inspection: 10/19/2023 Time: 03:00 PM
Age of Home: 16 Size: 2200

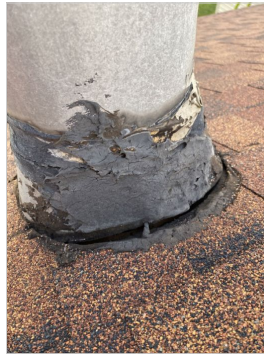
Furnace Roof Vent

4.2. Repair: **Flashing sealant around the furnace vent stack was deteriorated. This condition will allow water to enter the roof structure damaging it and other home systems. Recommend a roofing contractor evaluate and repair.**

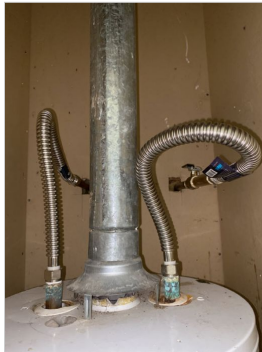
3.2. Repair: **Hose connections were not dielectric type. Dielectric unions should be used at dissimilar metal connections to prevent corrosion which will eventually leak. Recommend a qualified plumber evaluate and repair.**

Hose Connections not Dielectric

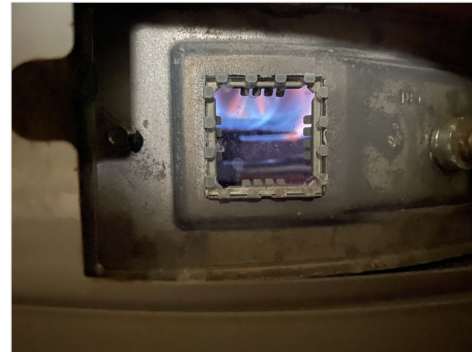
3.3. Flame Quality: **Burner flame was blue with orange highlights. Orange flames generally indicate insufficient combustion and debris on burner manifold. Recommend a qualified contractor evaluated and repair.**

Water Heater Flame

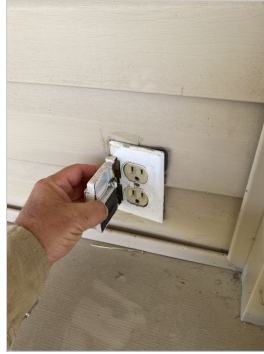
2.2. Safety: [Some locations requiring Ground fault circuit interrupters receptacles and arc fault circuit interrupters were missing. GFCI's are required to prevent electrical shock. AFCI's are required to prevent fires in the event electrical equipment is unplugged under load. This is a safety and fire hazard. Recommend an electrical contractor evaluate and repair.](#)

Not GFCI Protected

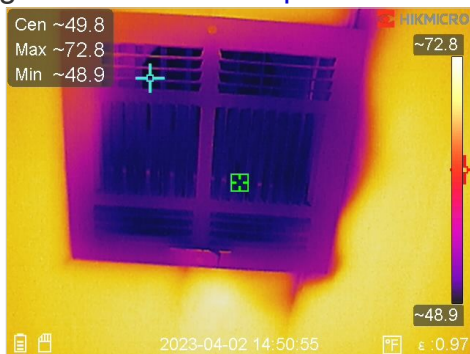
Supply Register Temp: 49.8°F

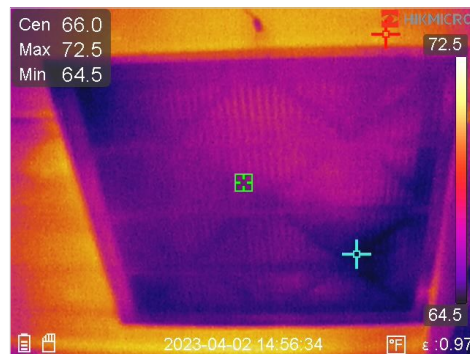
Return Air Temp: 66°F

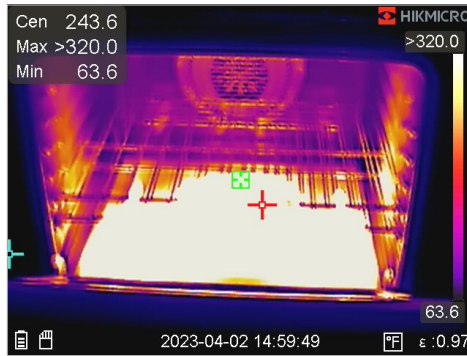
Oven Temp Set at 350: 320°F
