Advanced Home Inspections LLC

Property Inspection Report

Happy Ln, Lake Charles, LA 70605
Inspection prepared for: Donald Smith
Date of Inspection: 4/4/2022 Time: 01:00 PM
Age of Home: 10 Size: 1605

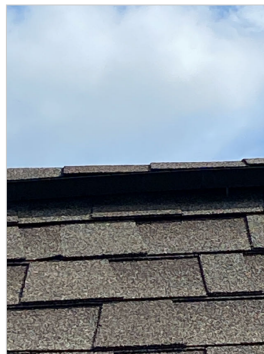
Ridge vent should be fastened to prevent pest and moisture intrusion to attic.

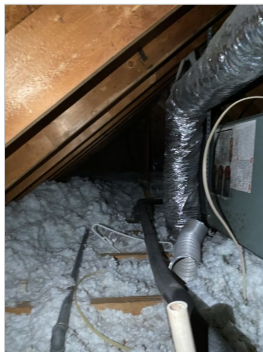
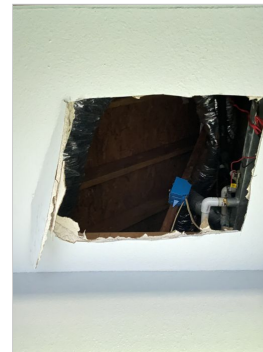
No Work Platform, Limited Access

No permanent attic access.

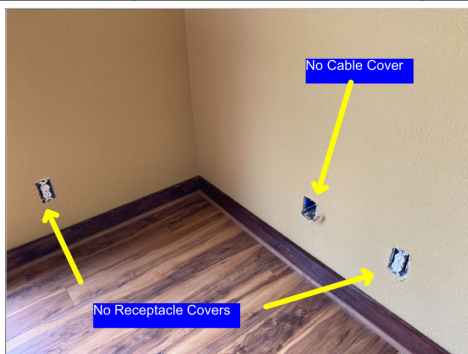
Electrical devices need covers. Some receptacles need replacement due to excess paint.

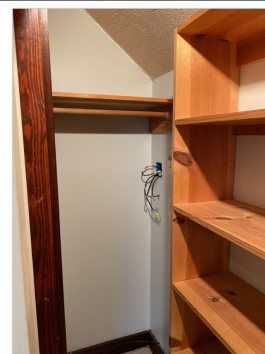
Wiring in upstairs bedroom-2 closet needs to be covered properly.

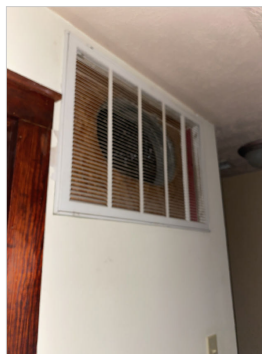
Return Upstairs: No filter was present.

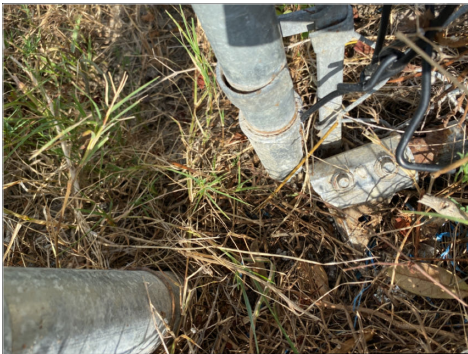
Gate fitting is cracked.

2.2. Repair: [Fence gate and related components were damaged. Recommend repair by a qualified fence contractor.](#)

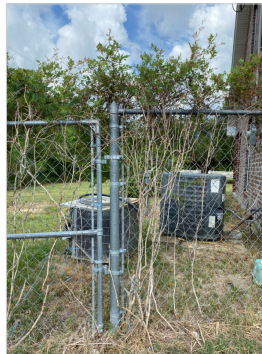
Gate not able to move due to vegetation growth.

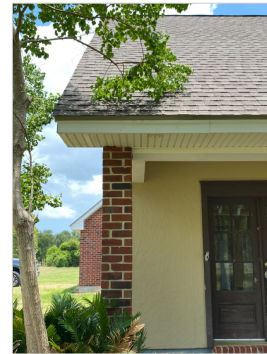
Front northwest corner has vegetation on roof.

2.3. Repair: [Vegetation was contacting roofing covering. Potential damage to shingles is likely. Recommend a professional remove limb or entire tree.](#)

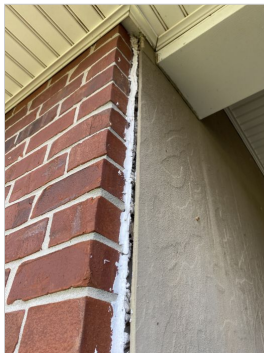
Carport wall should be resealed to brick.

2.1. Repair: Cement board to brick veneer sealant was deteriorated. Recommend qualified handyman repair.

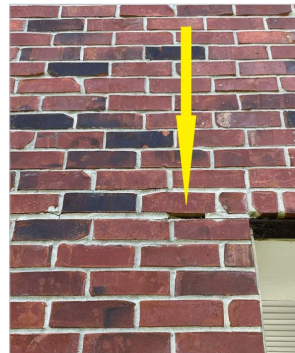
2.1. Repair: Few deficiencies were observed. A small amount of mortar was missing on left side of home. Recommend patching hole to prevent moisture and pest intrusion.

Mortar Missing

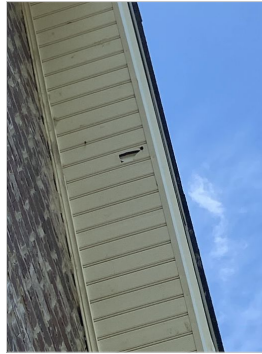
2.1. Repair: [Small hole in eave soffit on right side of home. Recommend a qualified person repair.](#)

Hole in soffit.

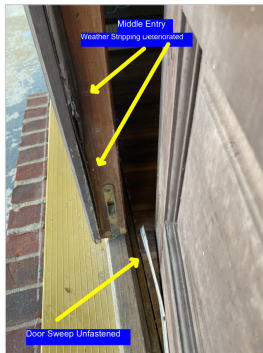
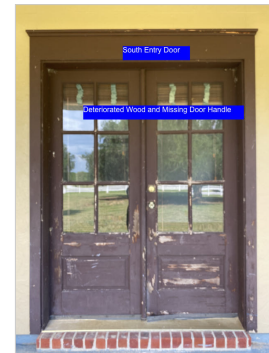
2.1. Repair: [Master bedroom entry door was missing outside door handle. Recommend a professional repair.](#)

2.2. Repair: [Light deterioration on door and trim surfaces. Recommend a qualified painter resurface to preserve wood.](#)

2.3. Repair: [Door sweeps on two exterior entry doors were partially unfastened. Contact a qualified handyman to repair.](#)

2.4. Repair: [Weatherstrip on the middle entry door was damaged. Contact a qualified contractor.](#)

Middle Entry Door weather stripping damage and unfastened door-sweep. South Entry Door: Coating deteriorated, missing handle.

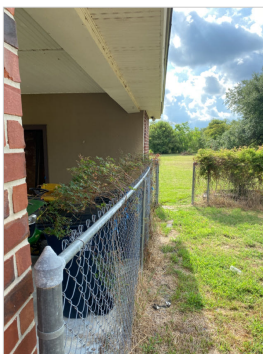
2.2. Safety: Carport fence had poison ivy which entered into walking area. Contact a landscaping contractor for safe removal.

Possible toxic vegetation on carport fence.

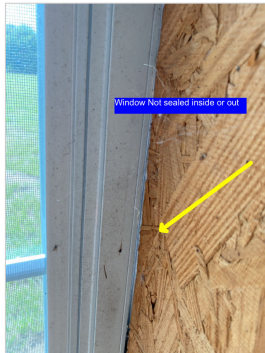
Window not sealed properly outside or inside.

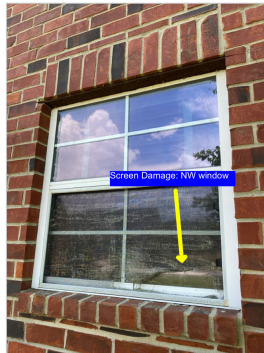
2.3. Repair: North wall screen was damaged. Recommend a professional replace screen.

Northwest Window: Screen damage.

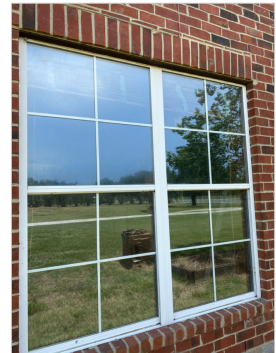
Windows not sealed.

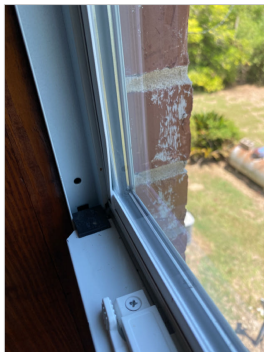
2.4. Safety: A window in the upstairs-bedroom-2 should have safety brackets installed to prevent fall hazard. This can be performed by a qualified handyman.

Recommend safety lock to prevent fall hazard.

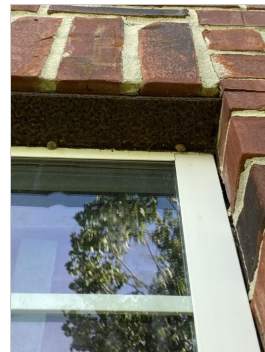
No seal. Lintel rusted.

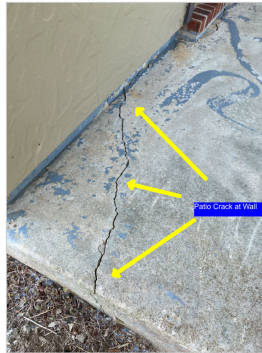
1.2. Repair: Concrete slab along front of home had cracking from possible settlement. Possible Cause: Lack of roof drainage. Contact a qualified contractor to evaluate and repair. Contact roof drainage contractor for gutter installations.

Front Patio: North end of lateral crack.

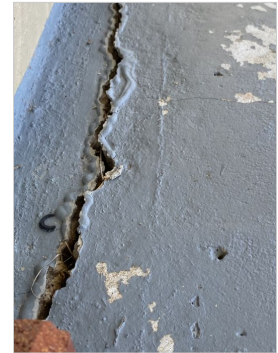
Crack along the wall.

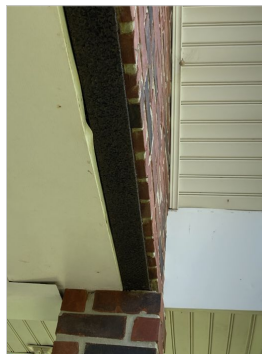
Rusted Lintel

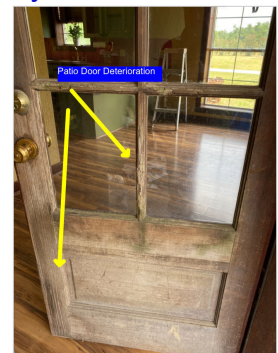
Rear patio door was deteriorated.

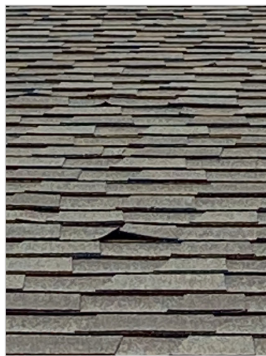
2.2. Repair: [A few shingles on the roof were not bonded during the inspection. Shingles should bond to provide wind resistance. Contact a qualified roofing contractor.](#)

Shingles not bonded

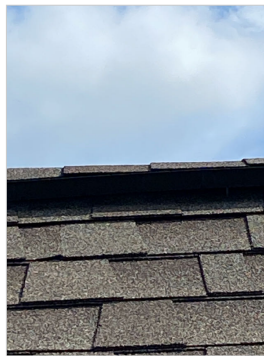
2.1. Repair: [Ridge vents not fastened. Recommend repair by qualified roofer.](#)

Ridge vent should be fastened to prevent pest and moisture intrusion to attic.

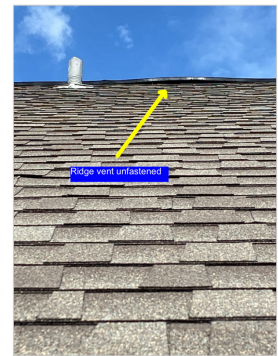
Ridge vent is unfastened in several areas.

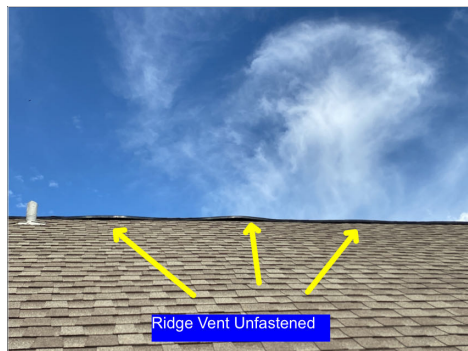
Ridge vent should be fastened to prevent pest and moisture intrusion to attic.

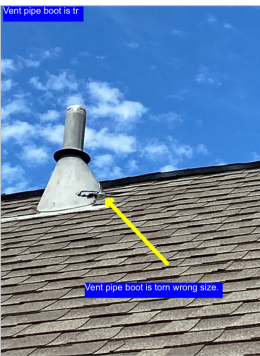
Vent pipe has an improper boot around base. Possible water intrusion spot.

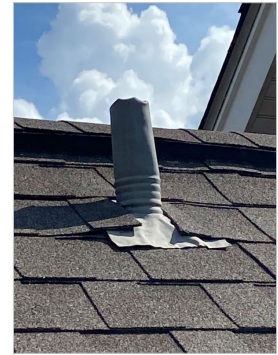
4.2. Repair: Shingles around vent pipe jacks were not installed neatly. Recommend repair if needed by qualified roofing contractor.

Shingles are not cut around the pipe jack neatly. Water intrusion is possible. Recommend roofing contractor evaluate and repair.

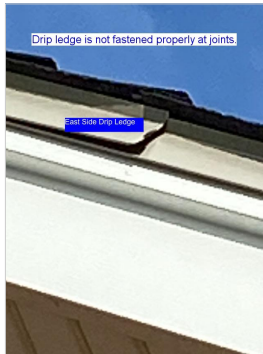
3.2. Repair: Location: Back of Shop. Drip ledge not fastened well at joints. Contact a qualified roofer.

Drip Ledge Joints not Fastened Properly

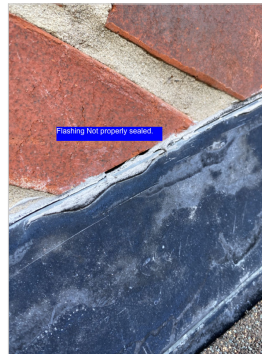
3.1. Repair: Northwest of carport. Sidewall flashing sealant was deteriorated and cracked. Recommend a qualified contractor replace sealant.

Carport wall flashing sealant should be removed and replaced with fresh sealant.

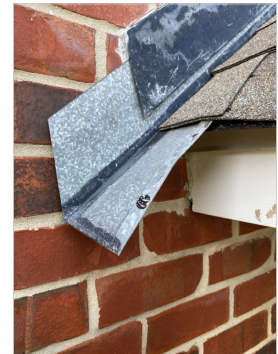
1.1. Repair: No roof drainage system was installed. System is necessary to channel roof drainage away from foundation. Recommend a qualified roof drainage contractor install drainage system.

Carport wall flashing extended for drainage. Gutters should be properly installed.

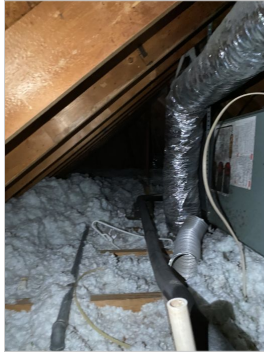
2.2. Repair: No access to attic above upstairs level where indoor furnace & evaporator unit is located. Access to ac units is required for maintenance. Recommend a qualified carpenter provide permanent access.

No Work Platform, Limited Access

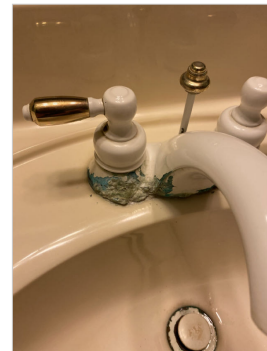
1.2. Location: Upstairs Bath Repair: Sink faucet leaked when cold water valve was turned on. Faucet had paint missing and metal corrosion causing faucet base to swell. Recommend replacing faucet by a qualified plumber.

Upstairs Bath faucet leaking and corroded.

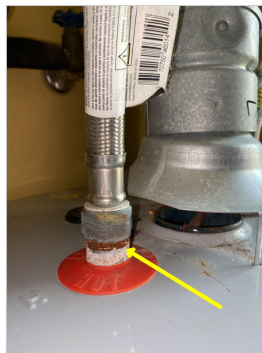
2.2. Repair: **The hot water hose connection to the water heater had corrosion. Recommend repair by a qualified plumbing contractor to prevent future water leaks.**

Water heater hot-side only corrosion.

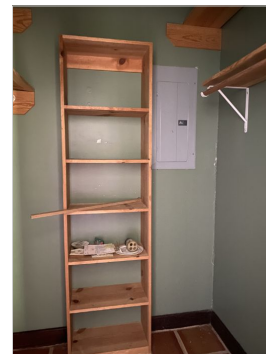
Insufficient clearance and next to clothes rack.

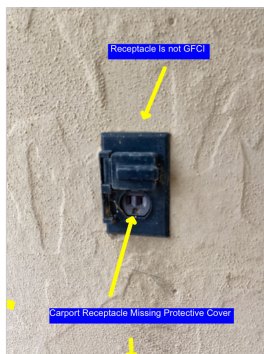
2.3. Safety: No receptacles were GFCI protected. Recommend a qualified electrician update receptacles for safety.

Carport receptacle is not GFCI protected and missing a safety cover.

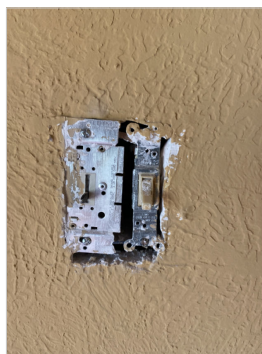
Dining room switch needs cover.

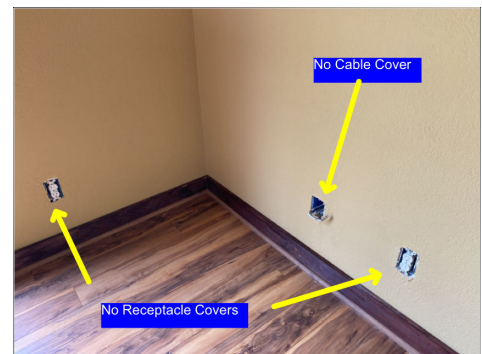
Electrical devices need covers. Some receptacles need replacement due to excess paint.

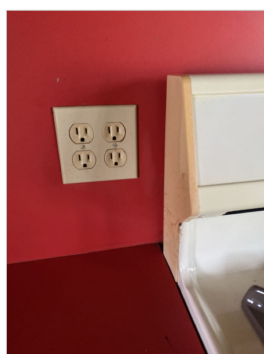
Kitchen receptacles are not GFCI protected.

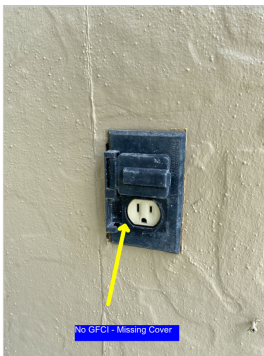
Front Patio: Not GFCI protected and missing weatherproof safety cover

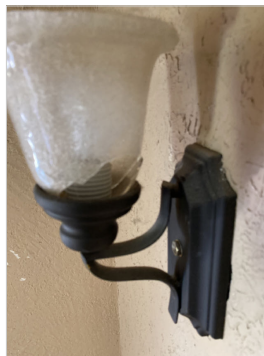
Stairway fixture glass shade cracked at base.

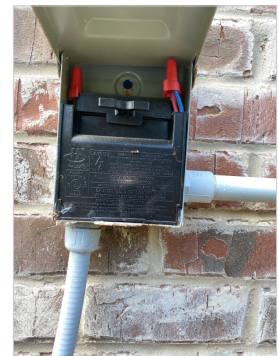
Improper device for electrical connection at condenser unit.

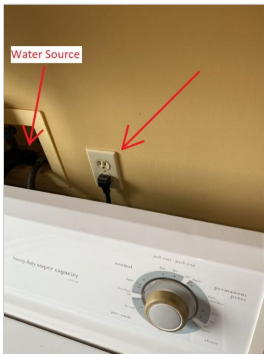
Washer receptacle not GFCI protected.

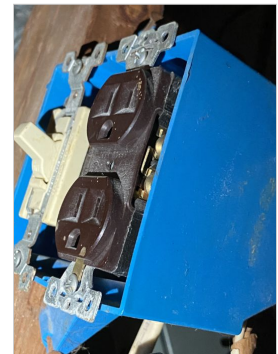
Missing cover for Indoor HVAC Unit power switch/receptacle.

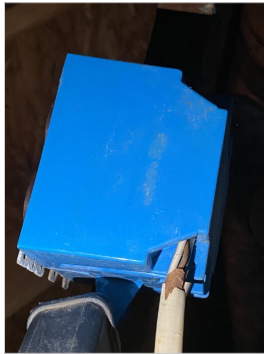
Missing cover for Indoor HVAC Unit power switch/receptacle.

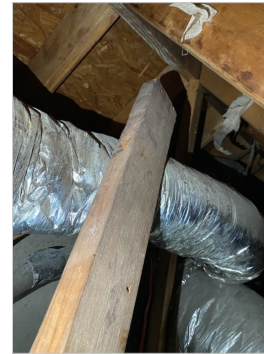
HVAC power switch in attic is not fastened on either end.

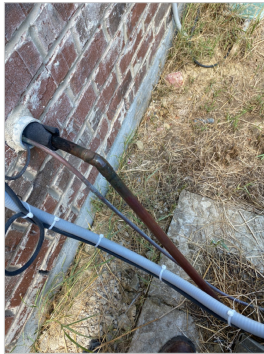
5.1. Repair: Insulation on the compressor suction line was not installed. Cold lines missing insulation will generate copious amounts of water and lose efficiency. Recommend qualified contractor install proper density foam rated for refrigerant line use.

Condenser suction line not insulated.

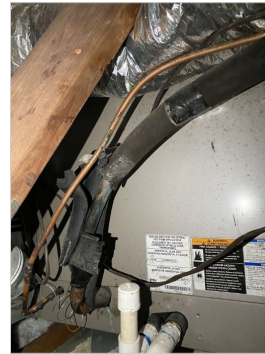
Missing Insulation

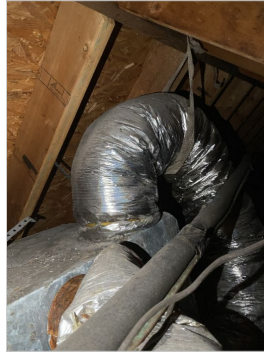
- 1.1. Repair: Air-handler supply branch connector was rusted. Rusted ducts can eventually have air leaks resulting in wasted energy. Recommend qualified contractor repair to prevent further damage.

Air Duct Rust

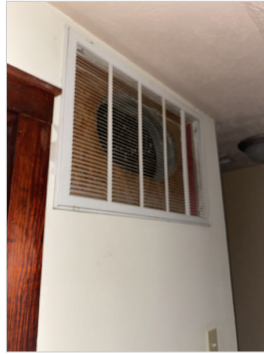
Return Upstairs: No filter was present.

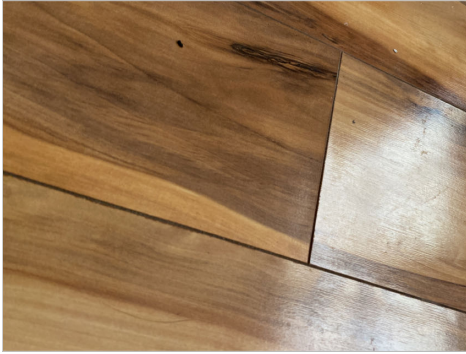
2.1. Repair: Living room and kitchen areas. Laminate flooring shows buckling at ends of tiles. Recommend a flooring contractor evaluate condition.

Kitchen laminate flooring buckling due to water exposure.

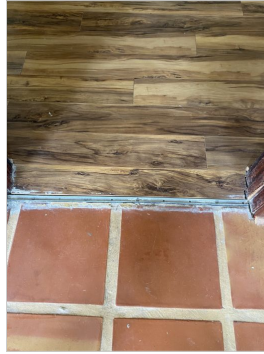
2.2. Location: Master Bed/Living Room Repair: Flooring transition-piece to living room missing. Contact a qualified handyman.

Transition strip is missing between master bedroom and living room.

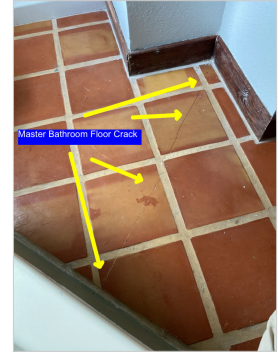
Master Bath: Tile had hair line crack.

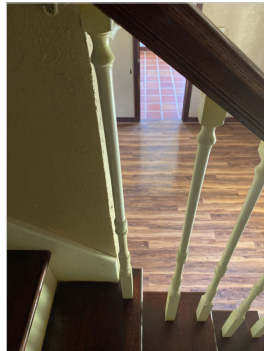
1.1. Safety: The staircase handrail assembly had spaces between balusters greater than 4-inches. Recommend altering handrail to improve child safety. Contact a qualified carpenter.

Balusters were spaced more than 4".

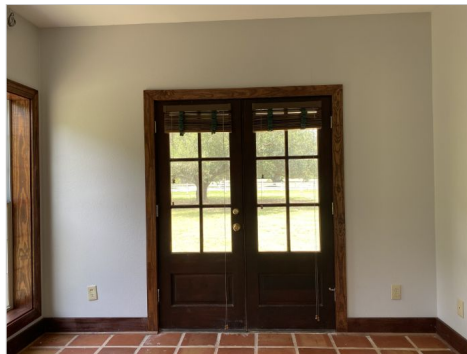
2.1. Repair: [Insulation missing in area over master bedroom. This can result in reduced comfort levels and increased energy costs. Recommend insulation be distributed to cover all portions of the attic located above the home living space where missing or of low depth. All work should be performed by a qualified contractor.](#)

Approximately 20ft long area above this door is missing insulation in attic.

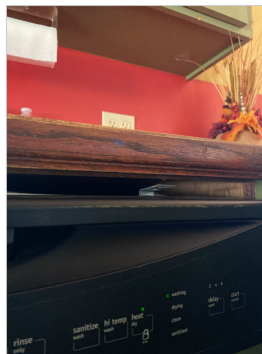
2.2. Repair: Dishwasher not mounted to cabinet. Recommend professional handyman.

Dishwasher needs to be properly supported to countertop.
