# ADVANCED HOME INSPECTIONS

## Property Inspection Report

123 Sample Court  
Lake Charles, LA 70605  
Age of Home: 2024 Size: 1885 sqft  
Weather: Sunny and Cloudy

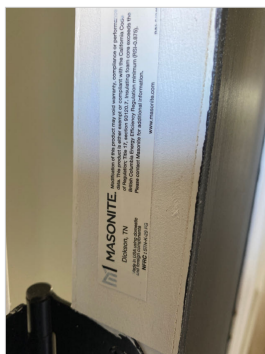
4.4. **Repair:** Front exterior door top hinge was loose. This prevented the door from opening and closing smoothly. Recommend a professional evaluate for proper size screws and tighten the hinge.

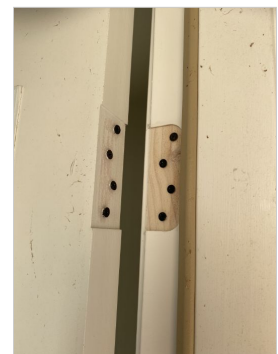
### Rear Entry Door

4.3. Repair: Rear entry door was missing the top hinge. Recommend a professional evaluate and install proper hinge.

*Rear Entry Door missing hinge.*

Update: Received information from realtor that the hinge is on order and will be installed by contractor.

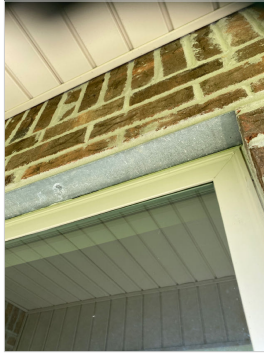
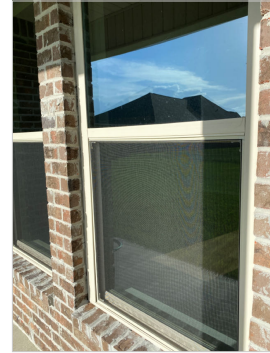
Repair: [Lack of sealant was applied around the outside of windows. This can moisture intrusion. Recommend a professional seal all windows.](#)

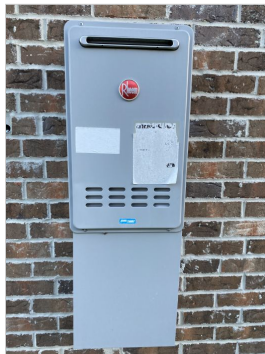
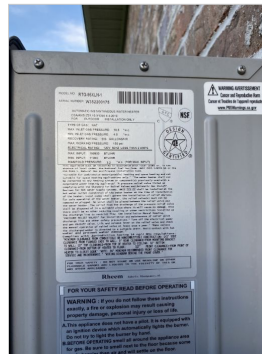
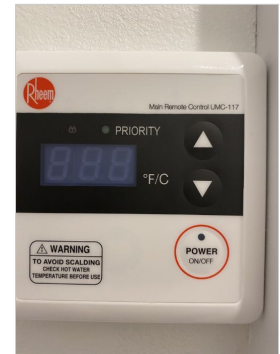
Operation: **Unable to perform testing due to utility gas meter not present during the inspection.**  
**Recommend the gas system for the entire home be tested for leaks when service is started.**

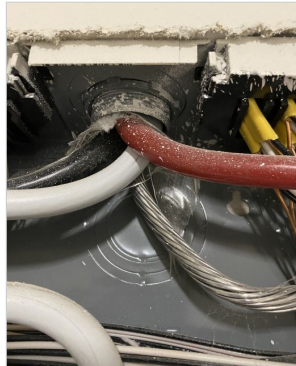
*No bushing on connector threads.*

Repair: No bushing was installed on the connector threads where the main conductors entered the panel. Recommend a qualified electrician evaluate and repair to prevent damage to conductor insulation.

Page 13 Item: 4	Panelboard Condition	<p>Repair: No bushing was installed on the connector threads where the main conductors entered the panel. Recommend a qualified electrician evaluate and repair to prevent damage to conductor insulation.</p>
-----------------	----------------------	--

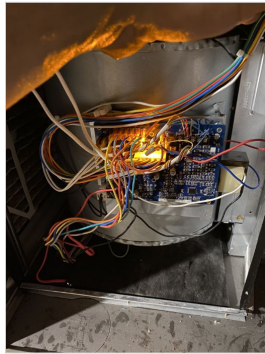
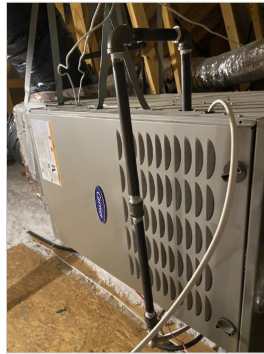
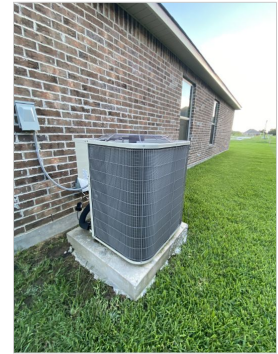
*Air Handler Drain Pipe Cleaning Access. Recommend installing a loose cap to prevent debris or lent from entering.*

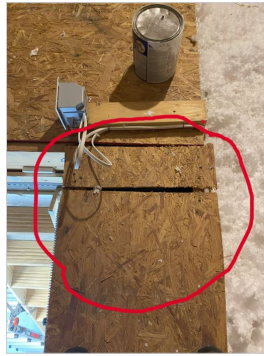
5.1. Safety Repair: The OSB particle board for attic flooring next to the attic access was not supported well. The board does not support weight and had a cracking sound when stepped on. Recommend a carpenter evaluate and repair to prevent personal injury while inside the attic space.
