ADVANCED HOME INSPECTIONS Property Inspection Report

Street, Lake Charles, LA 70607

Inspection prepared for: Loyal Customer

Date of Inspection: 9/22/2025 Time: 03:30 PM

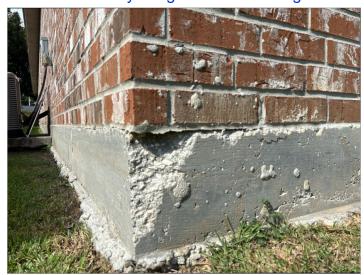
Front left corner of home missing foundation.

1.3. Repair: Some areas around the perimeter of concrete foundation slab surfaces were not smoothly finished. The issue is more cosmetic than structural. We recommend a contractor finish the foundation by filling in all holes with grout.

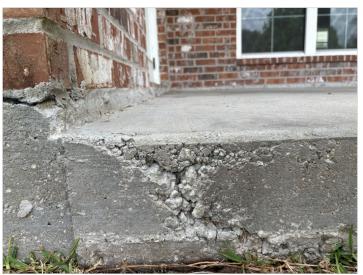
Concrete slab needs finishing repair.

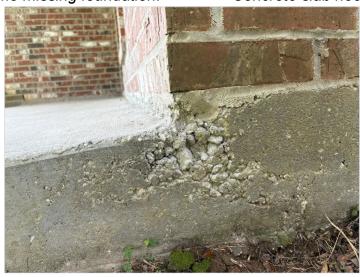
Concrete slab at front patio needs finishing.

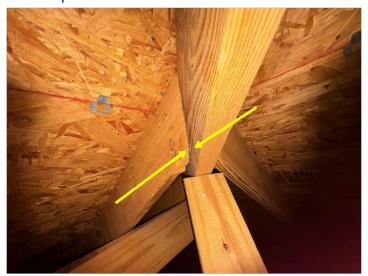
2.2. Repair: Significant size gaps were observed where the rafters are supposed to be fastened to the ridges. Fasteners at these points were not penetrating the ridge sufficiently. Recommend a contractor evaluate and make repairs.

1/2" Gap between rafter and ridge boards.

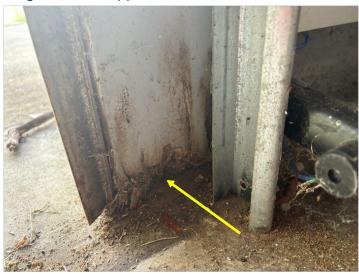
No sealant was applied to the garage door seal. Garage support board deterioration from moisture intrusion.

- 3.2. Pressure Sensitive Safety Reverse Feature: Inspected and Tested
- 3.3. Infrared Obstruction Safety Reverse: Inspected and Tested
- 3.4. Repair: Vertical boards supporting the garage door showed signs of wood decay and high moisture. The boards are partly touching and too close to the concrete. We recommend a qualified contractor evaluate and repair boards.
- 3.5. Repair: The garage door did not operate consistently from the remote control buttons. We recommend a garage door contractor evaluate and repair.
- 3.6. Repair: The garage door weather seal did not have sealant on the mounted surface. Significant gaps were observed where water can intrude and deteriorate the wooden garage door supports. We recommend a contractor evaluate and repair using a sealant approved for outdoor use.

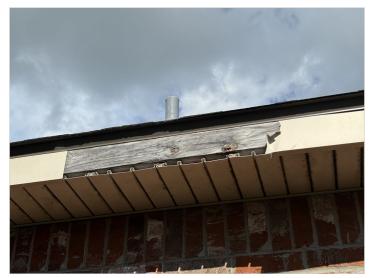
Exposed fascia board due to missing metal fascia covering.

- 6.4. Fascia Repair: A section of metal fascia cover was missing from the fascia board on the left side of house. We recommend a carpenter evaluate for further damage to the wood fascia board and make repairs.
- 6.5. Fascia Repair: The fascia above the garage was not fastened to the fascia board. The fascia board is open and will allow water intrusion. The wood fascia board will eventually decay if water intrusion is not mitigated. We recommend a contractor evaluate and repair.
- 6.6. Repair: Two lag bolts were observed driven into the fascia on the right side of home. Water can enter the fascia at these points and cause the fascia board to decay from wood rot. We recommend sealing around the screws or removing the screws and applying sealant in the hole. All sealant should be rated for outdoor use.

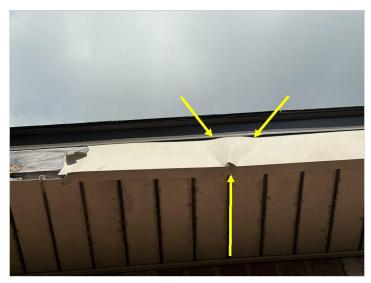
Damaged metal fascia.

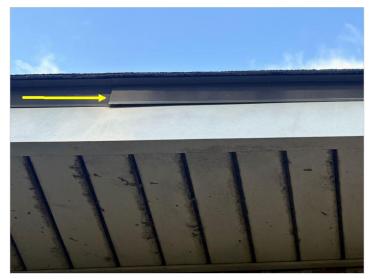
Drip edge joint not flush.

3.2. Repair: The roof drip edge was not neatly installed at some overlapping joints. Water can flow into the open gap and damage the roof sheathing, eaves and fascia boards. We recommend a contractor seal the drip edge joints not flush with a sealant approved for outdoor use.

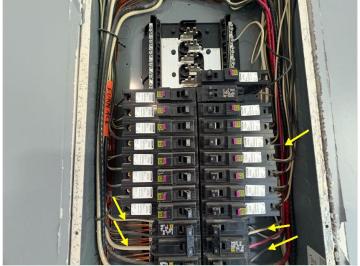
Branch circuit wires were not identified.

Repair: Electrical circuits were not properly labeled. We recommend an electrical contractor

evaluate ciruits and label them.

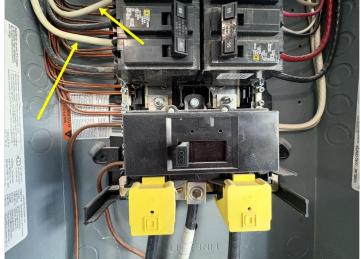
Repair: A white wire was used as a phase conductor. Phase wiring should be identified to distinguish the difference between neutral conductors. White and natural gray colors are designated for use on neutral conductors. We recommend an electrician evaluate and identify all circuits in the main electrical panel.

White wire not identified as phase conductor. Other wiring also was not identified.

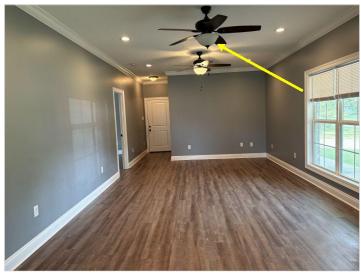
Light and fan did not operate.

- 4.1. Inspected: Yes
- 4.2. Ceiling Fan Operation: Satisfactory with exceptions, see notes.
- 4.3. Light Fixture Operation: Satisfactory
- 4.4. Switches Operation: Satisfactory with exceptions, see notes.
- 4.5. Receptacle Polarity and Ground: Satisfactory
- 4.6. Ground Fault Circuit Interrupter Operation: Satisfactory. All GFCI were protected using rated circuit breakers.
- 4.7. Arc Fault Circuit Interrupter Operation: Satisfactory
- 4.8. Repair: The living room ceiling fan/light nearest the kitchen did not function. We recommend a licensed electrician evaluate and repair.
- 4.9. Repair: Some light switches located at front, rear and garage entrances did not operate any lights or fans. We recommend a licensed electrician evaluate and repair.

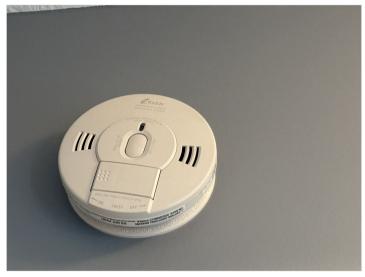
Smoke alarm near indoor AC unit did not function.

5.1. Repair: Two smoke detectors located outside bedroom areas did not function during the inspection. The detectors were a different model than other detectors. The state of Louisiana requires that all homes being sold must have working smoke detectors installed in required locations. Typical locations are one in each bedroom, one outside bedroom areas, and one in living kitchen area. Louisiana now requires one carbon monoxide detector to be installed in the home even if there is no gas utility in the home. The CO detector can be a CO-Smoke combination type. All detectors shall be installed with a 10-year lithium battery. Due to frequent code changes we recommend an electrical contractor evaluate the proper locations and install the detectors.

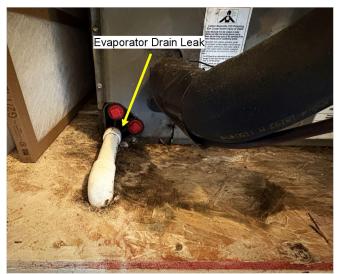
Evaporator drain leak.

2.5. Repair: The evaporator condensate drain was leaking at the connection point to the unit. Condensate must be drained properly to prevent it from draining to undesirable areas and damaging other home systems such as drywall, wood framing and flooring. We recommend an HVAC contractor evaluate and repair the condensate drain line.

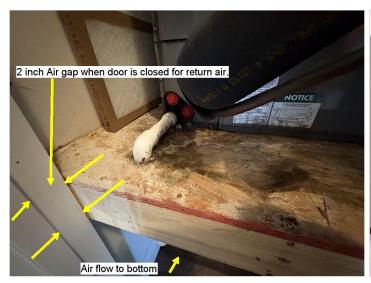
Illustration showing the area not filtered when the door is closed. Note: The filter in located inside the hallway access door.

2.4. Repair: The evaporator coils were excessively clogged with dirt. Condensation combined with water have caused the coils to corrode shortening the lifespan of the system. The return air filter was located in the hallway access door. When the door was closed, a 2 inch gap was between the filter and air handler. The gap allowed air to be pulled from the attic through the ceiling penetrations. We recommend a contractor repair or replace the evaporator coil after evaluation to prevent further damage to the coils. We also recommend a contractor evaluate and make changes to the return air filter to eliminate dirt entry to the evaporator coils.

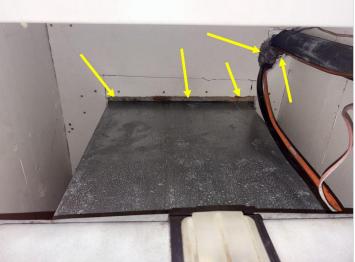
Air pulled in from attic through duct and refrigerant line penetrations was bypassing the filter. The contaminated air has clogged the evaporator.

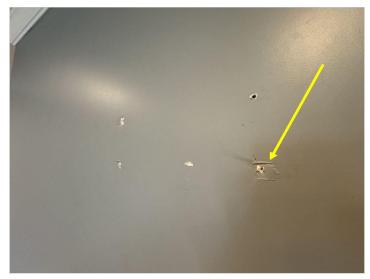
Random holes were in the living room, master bedroom, other bedrooms and bathroom walls.

1.2. Repair: Holes were observed behind most room entry doors from the door know striking the wall. Some holes existed in the living room and bedroom walls. We recommend a contractor make all repairs and installing door stops on all interior doors to avoid damaging the walls.

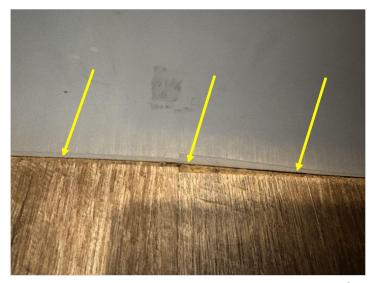
Master bathroom tub base was not sealed at the floor.

4.2. Repair: Located in the master bathroom, the floor covering haf significant gaps at the base of bathtub. We recommend a contractor evaluate and make repairs to prevent water intrusion into the floor covering. A high quality waterproofing sealant is recommended.

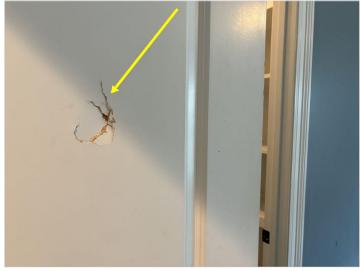
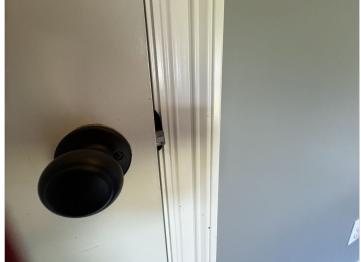
Front-left bedroom closet door would not latch closed.

5.4. Repair: The front-left bedroom entry door had significant play when shut. We recommend a contractor evaluate and adjust the door latching plate to reduce the gaps and play.

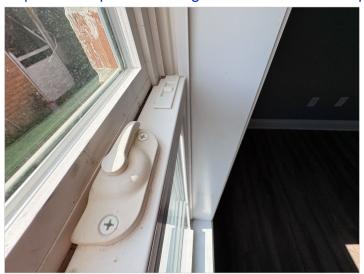
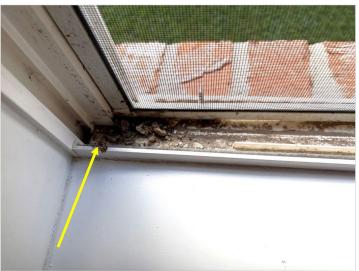
Pest intrusion due to bent window screen.

6.4. Repair: Windows with damaged screens had pest intrusion. We recommend a contractor replace or repair all damaged window screens to prevent pest intrusion.

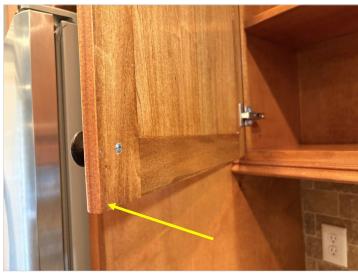
Missing a contact softener pad.

7.1. Repair: Some cabinet doors were missing a softening strike pad. The cabinet door were not self closing. The door could be damaged from high impact over time. We recommend installing felt, rubber or silicone pads on inside of doors.

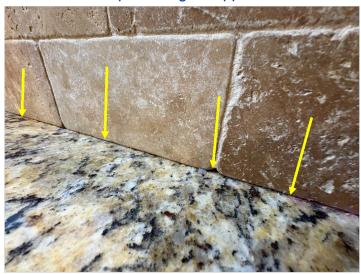
No sealant was applied between countertop and back-splash.

8.3. Repair: No sealant was applied at the joint between the countertop and back-splash. We recommend a contractor evaluate and repair using an approved sealant.

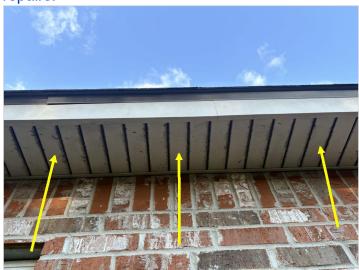
Soffits had no vents for attic ventilation.

No soffit vents were installed around the home.

3.2. Repair: The soffit around the perimeter of home did not have any ventilation panels installed. There was not way for attic air to flow. An attic with ridge vents should have ventilation panels in the soffit so that air will flow through the soffit into the attic and then upwards to the ridge vent. We recommend a vinyl contractor evaluate and make repairs.
