ADVANCED HOME INSPECTIONS

Property Inspection Report

Date of Inspection: 5/5/2026

Inspector: Jamie Beauxis LA#11291

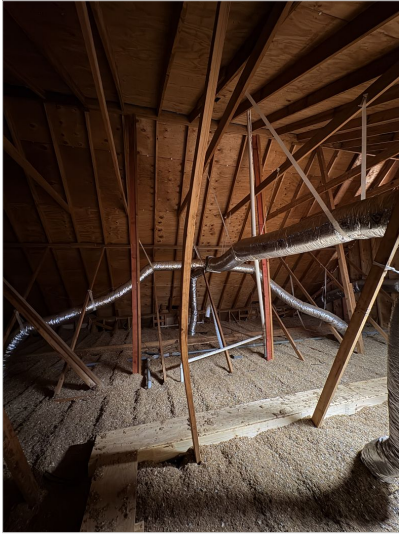
3.2. Observation: [A purlin support board in the attic was observed to be warped.](#)

Implication: [Warped supports can reduce the structural integrity of the roof system by failing to provide uniform support to the rafters. Proper support requires these members to be straight and, for spans exceeding 8 feet, reinforced with T-back bracing to prevent future bowing or failure.](#)

Warped purling support board.

Recommendation: [We recommend a qualified carpenter evaluate the warped board and replace it with a straight, properly braced support to maximize roof stability.](#)

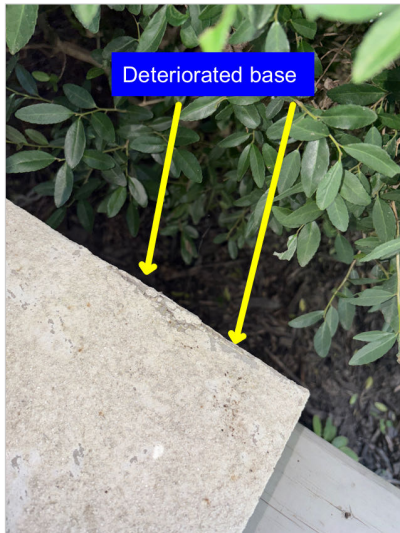
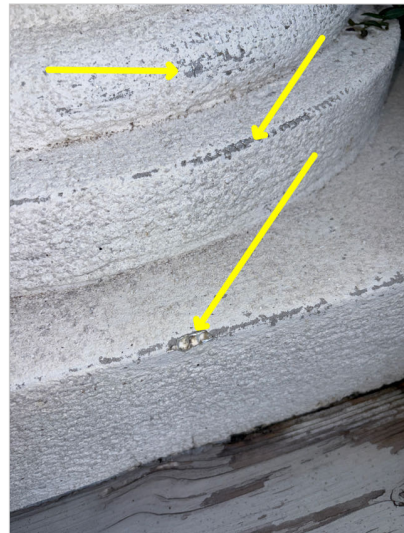
7.2. Observation: The surface coating at the base of the front columns was deteriorated, with chipping that exposed the underlying material.

Implication: Deteriorated coatings may allow moisture intrusion and could lead to deterioration of underlying components over time.

Column base was deteriorated.

Column base deterioration.

Recommendation: Repair of the affected areas is recommended to restore the protective surface.

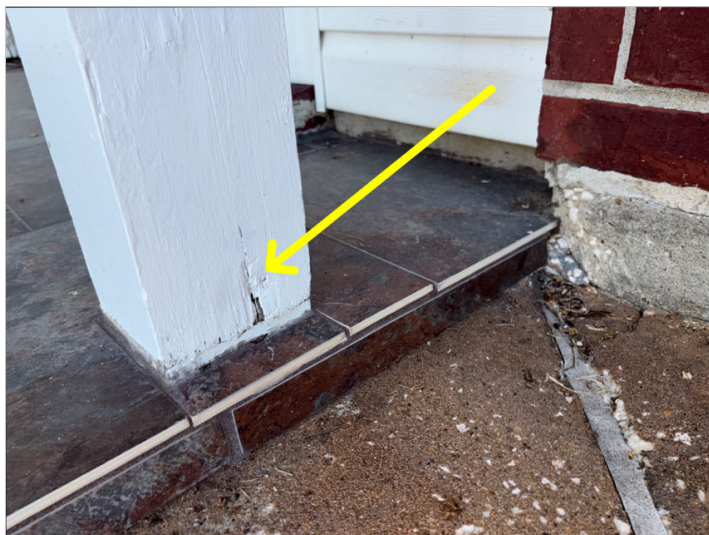
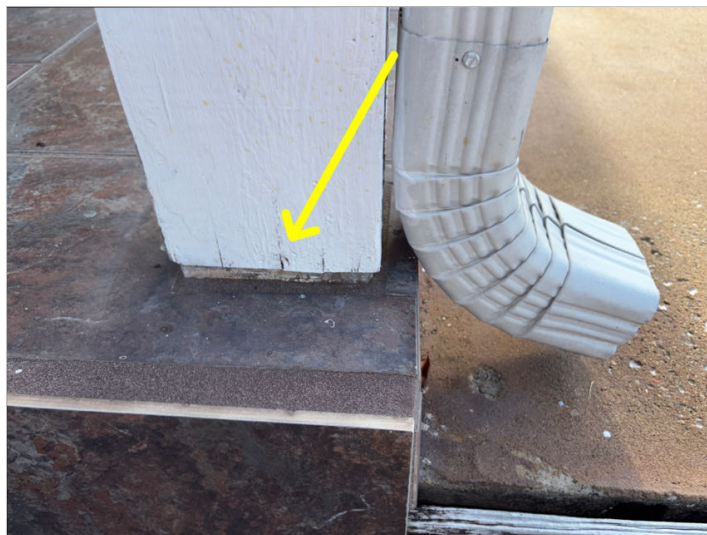
7.3. Observation: Moisture-related deterioration and wood decay were observed at the bases of the rear balcony columns.

Implication: The observed decay indicates compromised wood components and may reduce the load-carrying capacity of the columns over time.

Two of the rear balcony columns were deteriorated.

Recommendation: Further evaluation and repair or replacement by a qualified contractor is recommended.

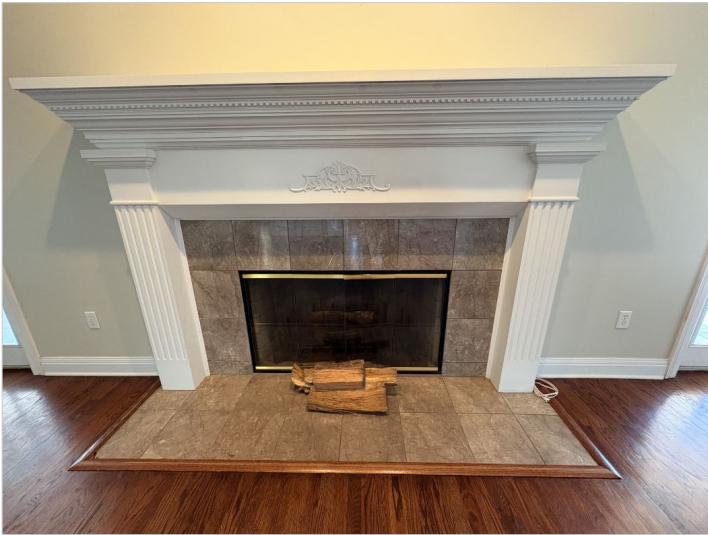
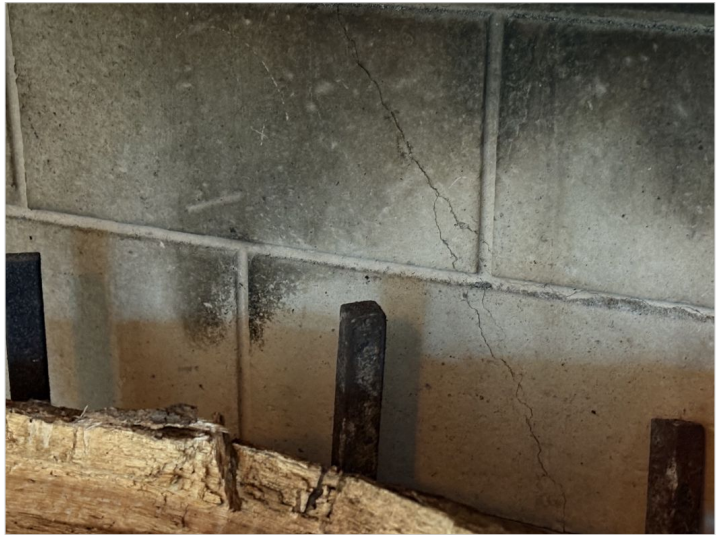
Crack was observed in rear side of fireplace.

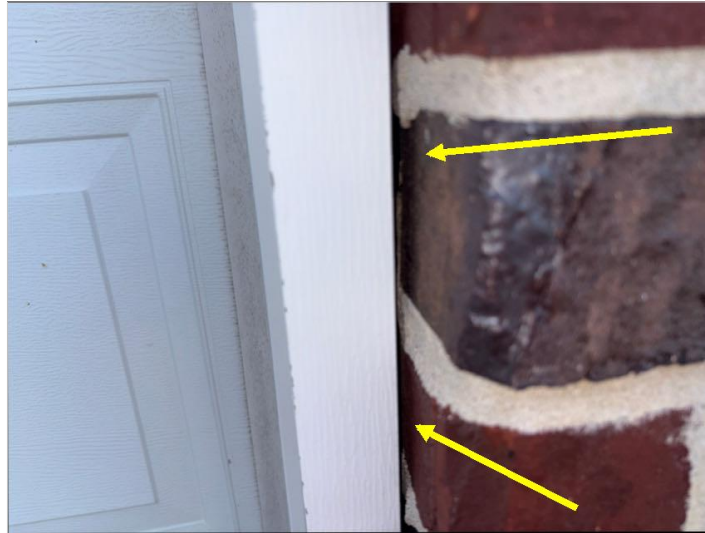
*No sealant was applied between support board and brick. Located at pool area garage roll up door.
(Closeup Photo)*

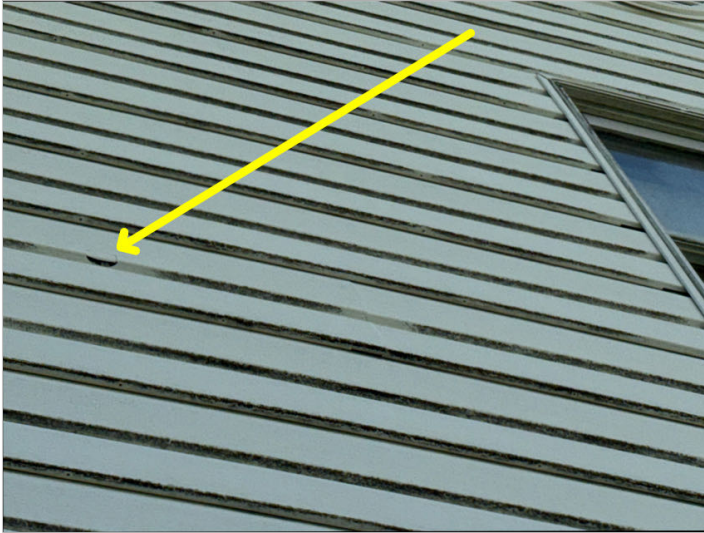
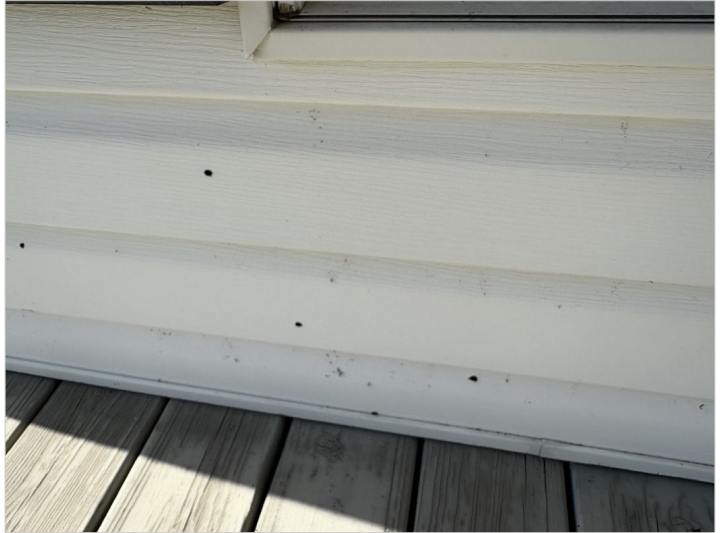
2.2. Observation: A hole was observed in the vinyl siding at the upper right side of the home.

Implication: The opening may allow moisture or pests to enter and could lead to deterioration of underlying wall components over time.

Small hole in vinyl siding.

Small holes observed in vinyl siding above front deck.

Recommendation: Repair is recommended to seal or replace the affected siding and maintain a weather-resistant exterior.

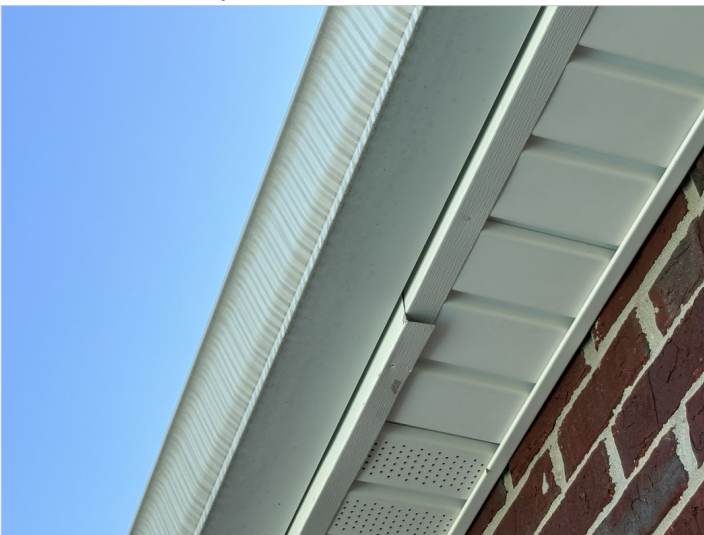
Fascia needs to be secured to prevent moisture from traveling to boards behind fascia.

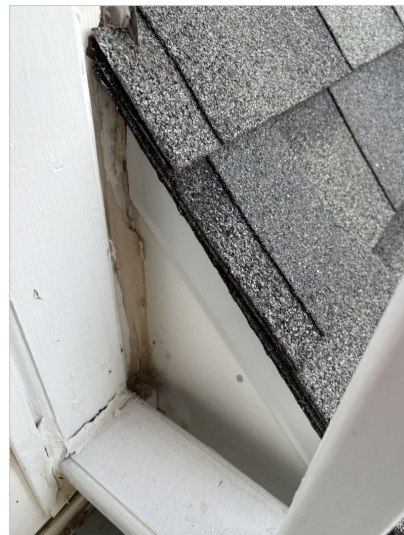
Area of concern for potential water damage located at balcony rail.

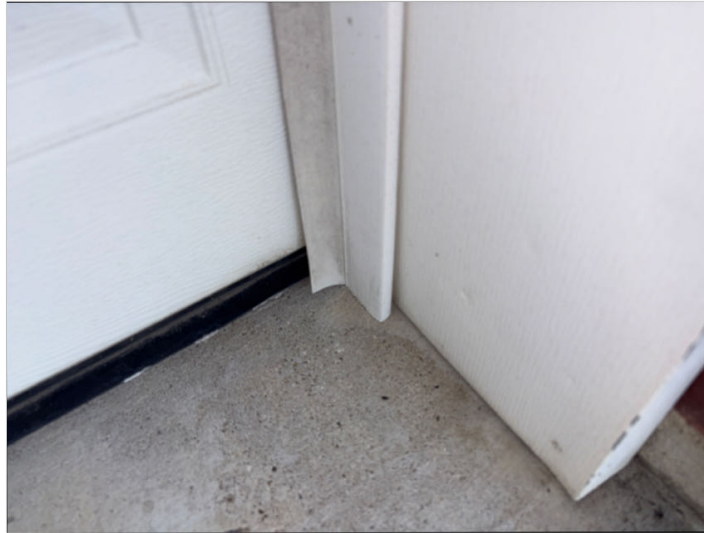
Garage door weather seal needs to be secured at bottom.

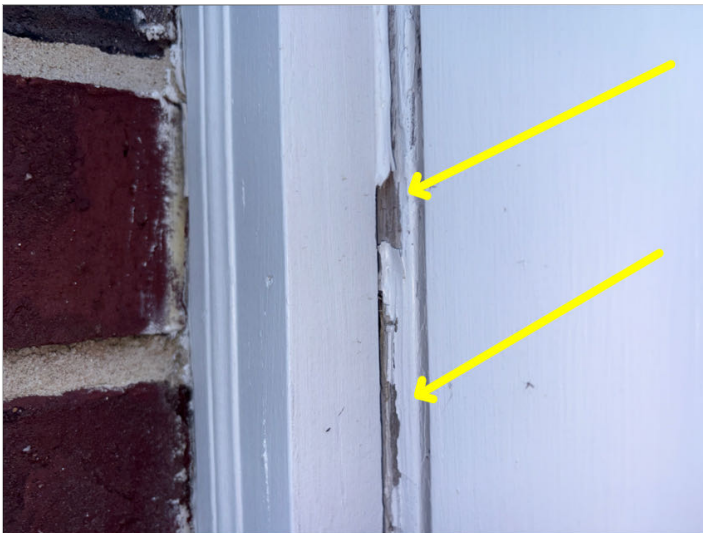
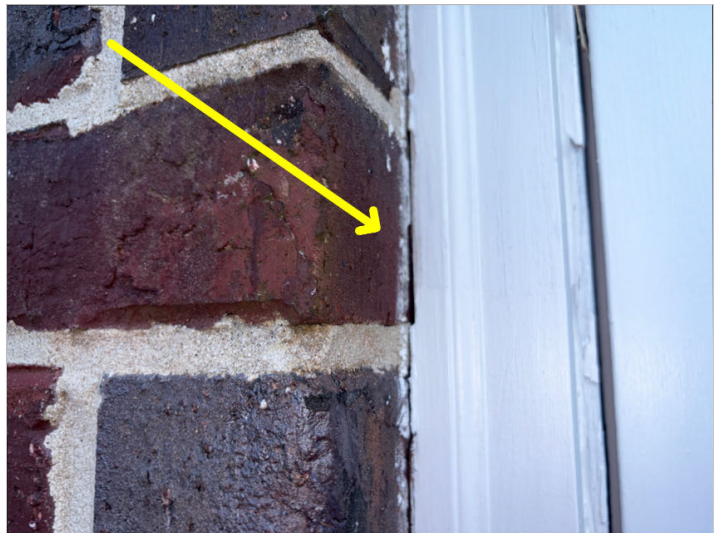
6.2. Observation: Deterioration of sealant was observed at the rear garage double-door where the frame meets the brick veneer.

Implication: Compromised sealant may allow moisture or pests to enter and could lead to deterioration of surrounding components over time.

Rear garage entry door frame casing sealant deterioration.

Rear garage entry door frame to brick sealant deterioration.

Recommendation: Resealing of the door perimeter is recommended to maintain a weather-resistant assembly.

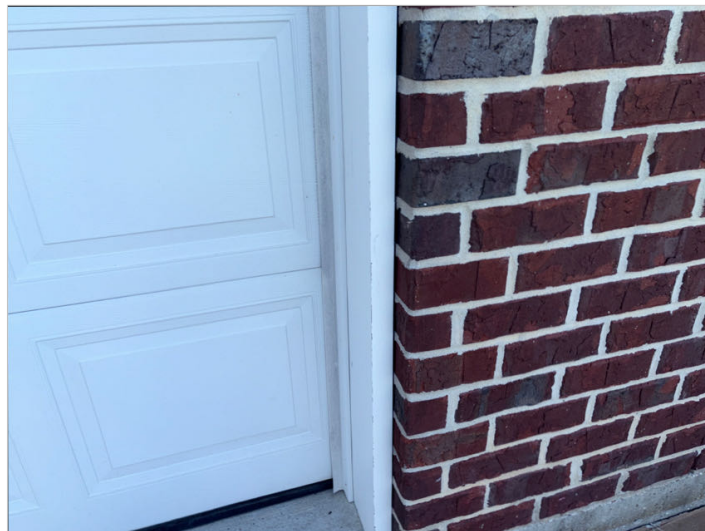
No sealant was applied between support board and brick. Located at pool area garage roll up door.

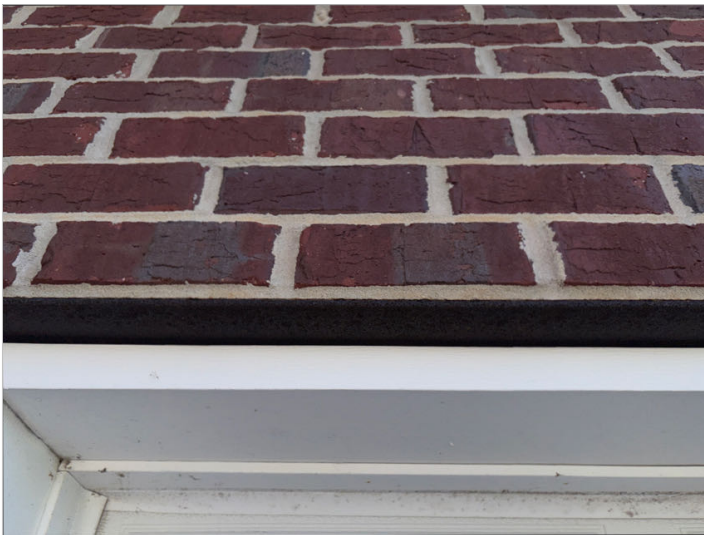
Sealant needed above window.

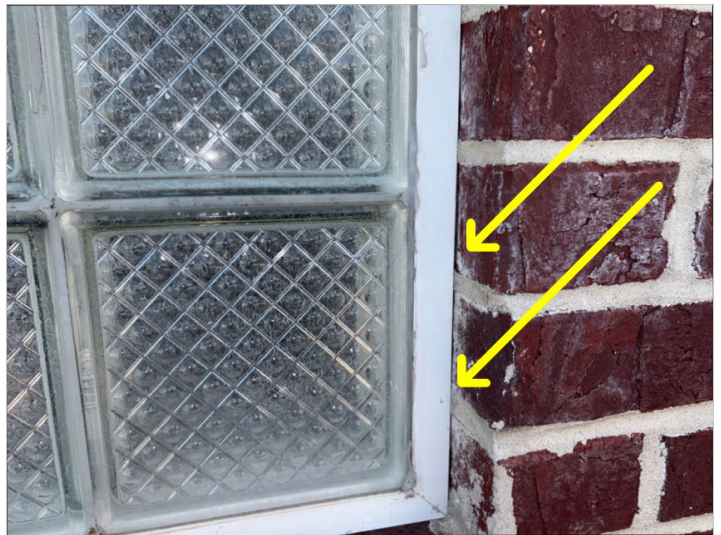
Sealant needed around bathroom window and brick siding.

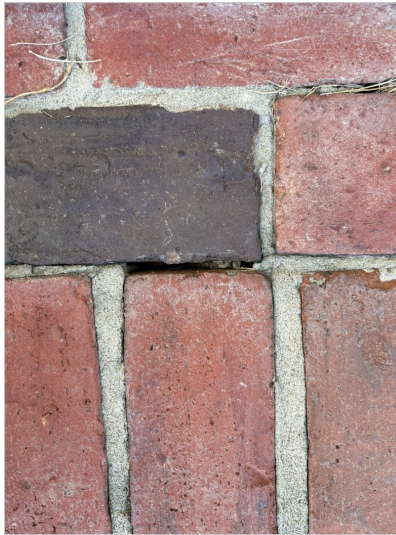
Brick mortar has deteriorated between some bricks. Moisture intrusion is possible to area beneath the front deck.

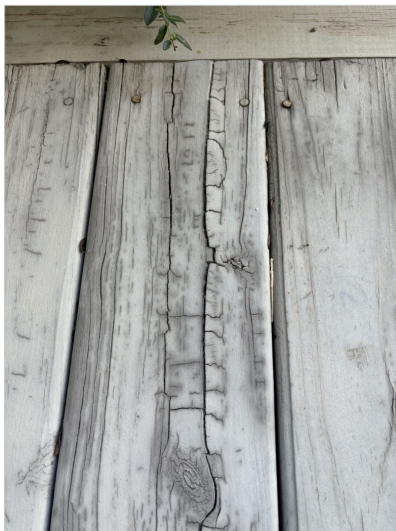
9.3. Observation: [Paint on several decking boards was observed to be deteriorated.](#)

Implication: [Deteriorated paint can allow moisture to contact the wood, which may lead to deterioration over time.](#)

Recommendation: [Cleaning, preparation, and repainting of the affected decking to help protect the wood from moisture intrusion is recommended.](#)

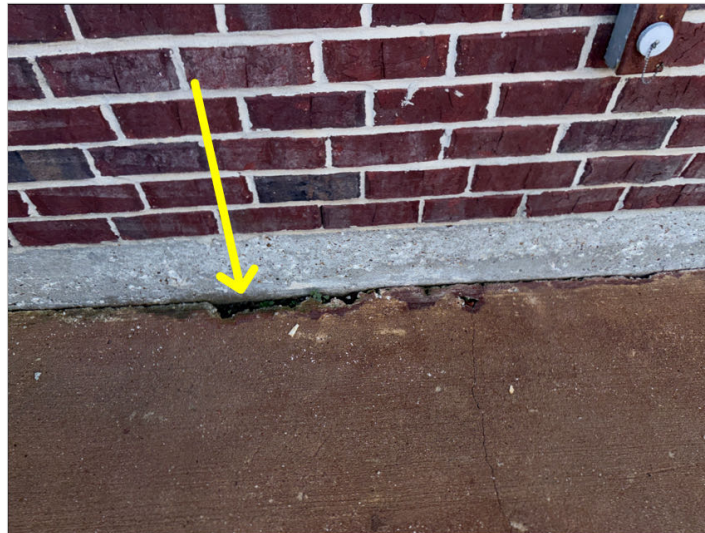
10.2. Observation: The junction between the rear patio concrete slab and the house foundation was observed to be open due to deteriorated sealant beneath the master bathroom window.

Implication: An open joint at this location can allow water intrusion at the foundation interface, which may contribute to moisture-related deterioration over time.

Deteriorated concrete on rear patio at foundation below master bath window. Recommend a contractor evaluate and repair.

Recommendation: Sealing of the joint with an appropriate exterior sealant to help prevent moisture intrusion is recommended.

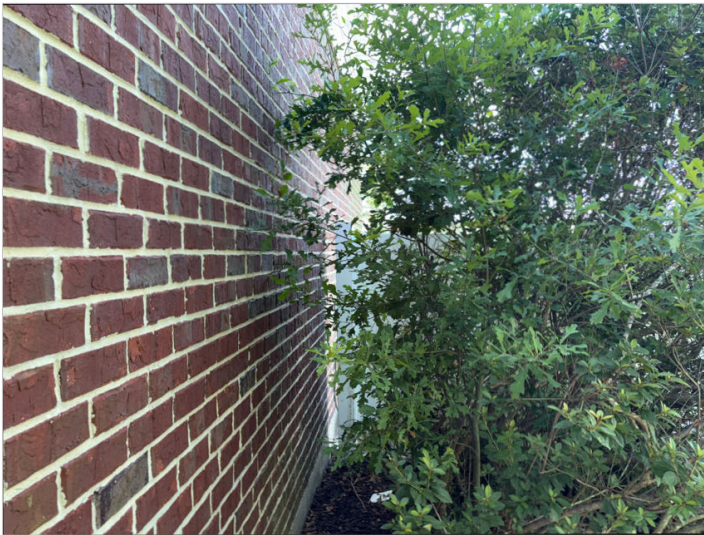
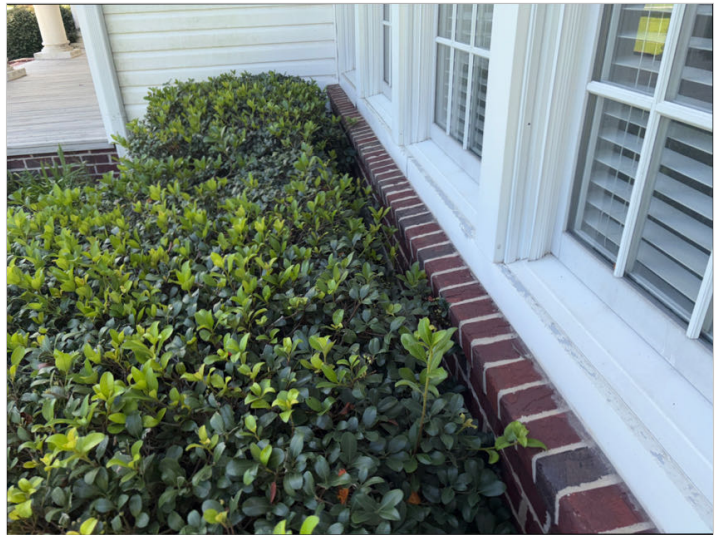
12.2. Observation: Landscaping shrubs were observed to be overgrown against the foundation and front columns.

Implication: Vegetation in contact with the structure can trap moisture against exterior surfaces and may facilitate pest access.

Vegetation in contact with home.

Recommendation: Trimming of vegetation to provide clearance from the structure is recommended.

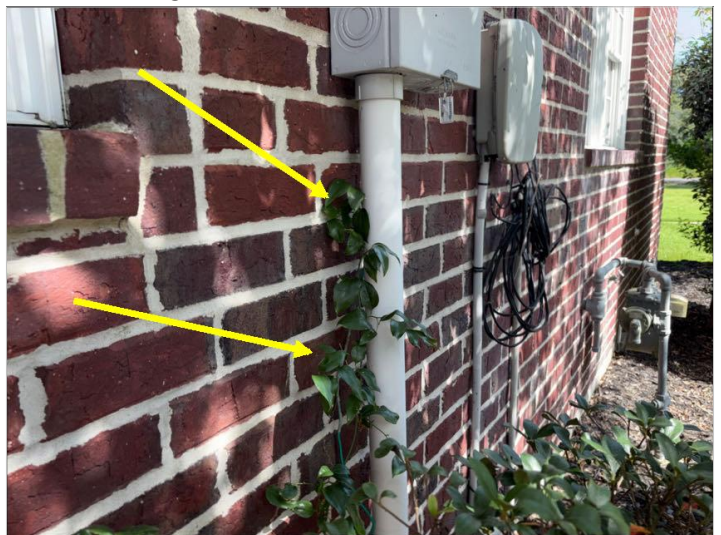
Vine growing toward electrical utility meter.

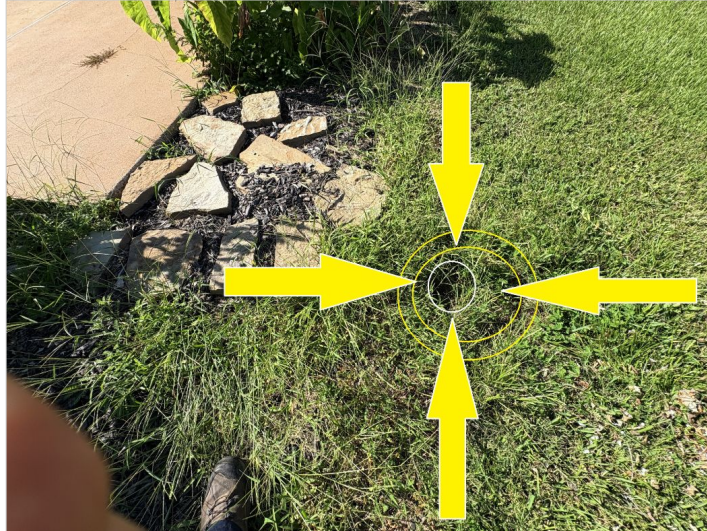
Significantly deep hole.

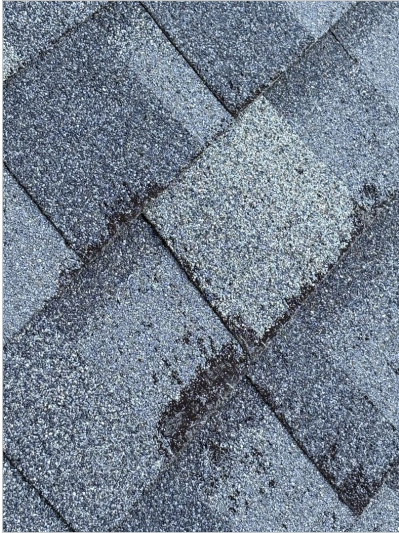
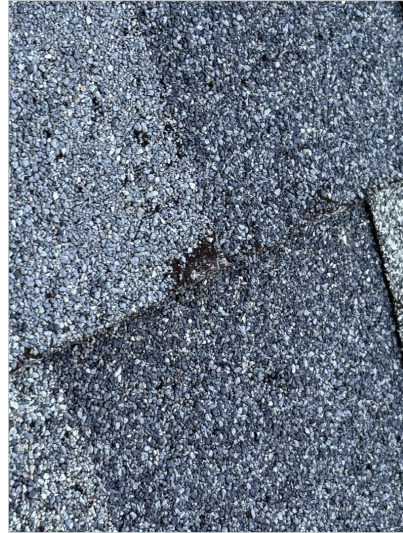
Some shingle granules were missing.

Area with granules removed from shingles.

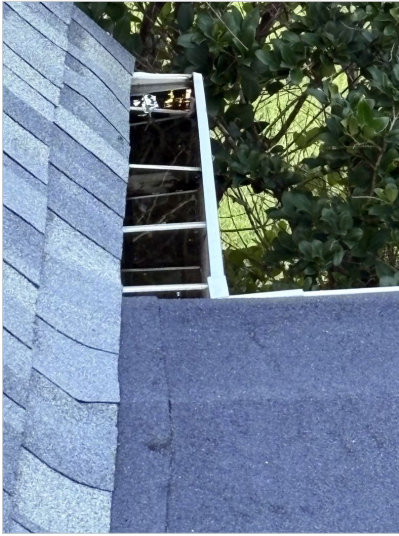
2.2. Observation: Water was observed to be standing in the front gutter system.

Implication: Standing water can place additional load on the gutter system and may indicate improper drainage.

Front right side of home gutters were not draining due to being clogged.

Recommendation: Evaluation and correction of the gutter system as needed to promote proper drainage is recommended.

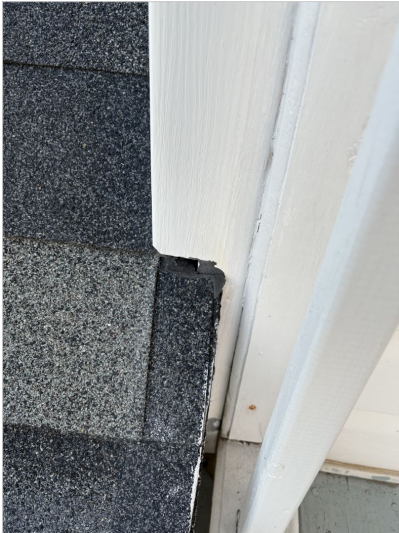
Insufficient flashing and sealant located at end of balcony.

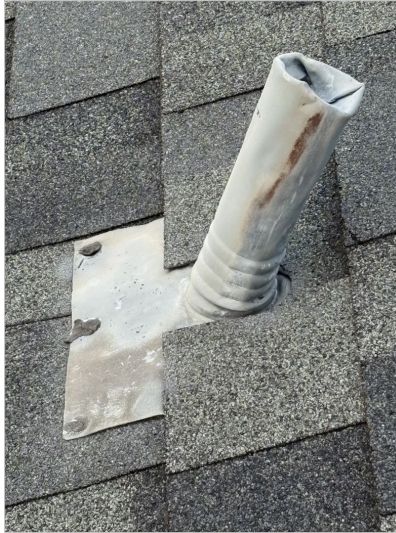
4.2. Observations: : Fasteners were observed to be installed through flashing at roof penetrations on the downhill side.

Implication: Fasteners installed in the drainage path of flashing can be susceptible to leakage, particularly as sealant deteriorates over time.

All roof penetrations had fasteners installed in the exposed flashing. The fasteners were sealed.

Recommendation: Correction of the affected roof penetrations, including sealing of exposed fasteners as needed by a qualified roofing contractor, is recommended.

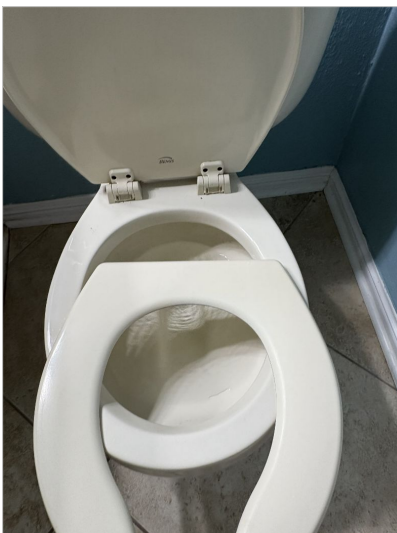
Toilet seat hinges damaged. Located bathroom #4 with double sink.

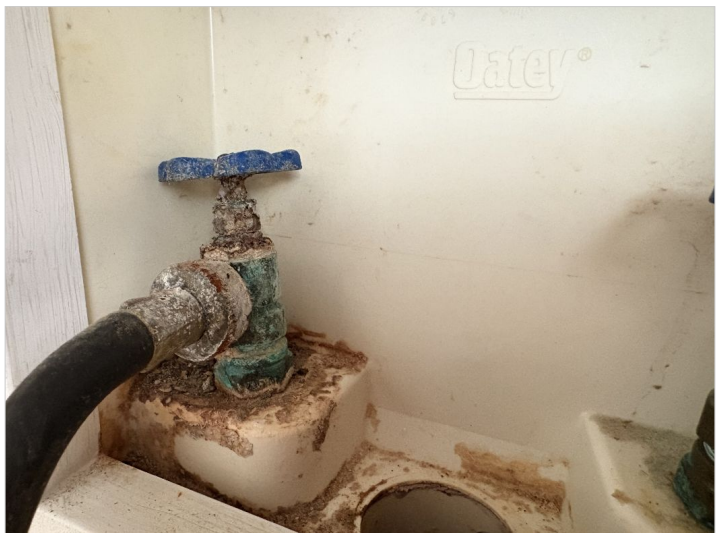
Washing machine hose bib significantly corroded.

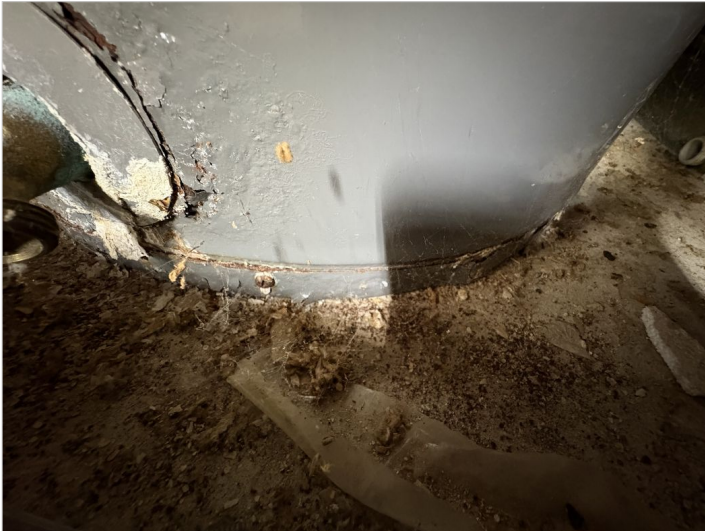
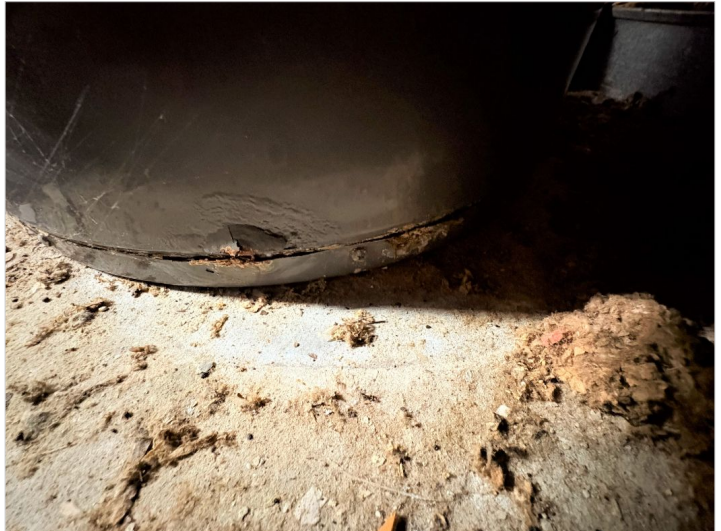
Electric water heater at rear left side of home showed signs of deterioration.

Tank was showing signs of rust.

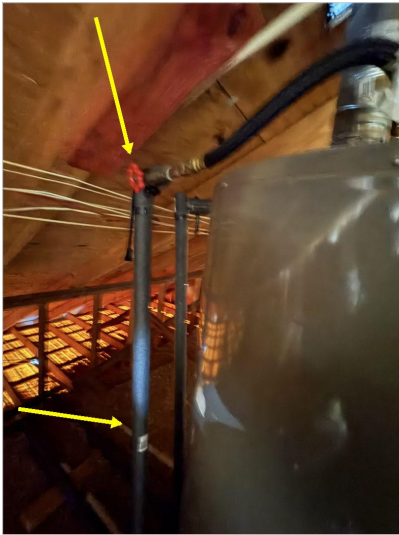
5.4. Observation: Water supply and distribution lines connected to the water heater were observed to be inadequately supported.

Implication: Inadequate support can place stress on piping and connections, which may lead to leakage over time.

Water lines not supported.

Recommendation: Evaluation and correction of the piping support as needed by a qualified plumbing contractor is recommended.

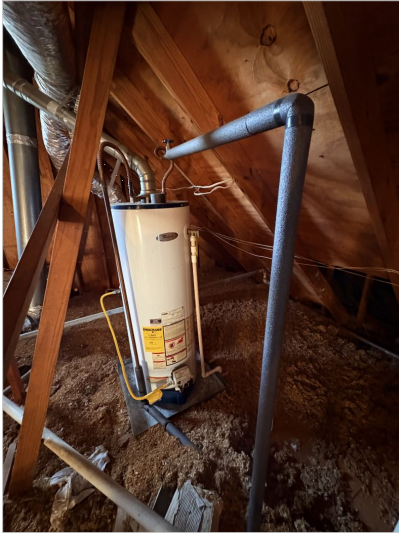
6.3. Observation: [Water supply and distribution lines connected to the water heater were observed to be inadequately supported.](#)

Implication: [Inadequate support can place stress on piping and connections, which may lead to leakage over time.](#)

Water lines were not supported sufficiently.

Recommendation: [Evaluation and correction of the piping support as needed by a qualified plumbing contractor is recommended.](#)

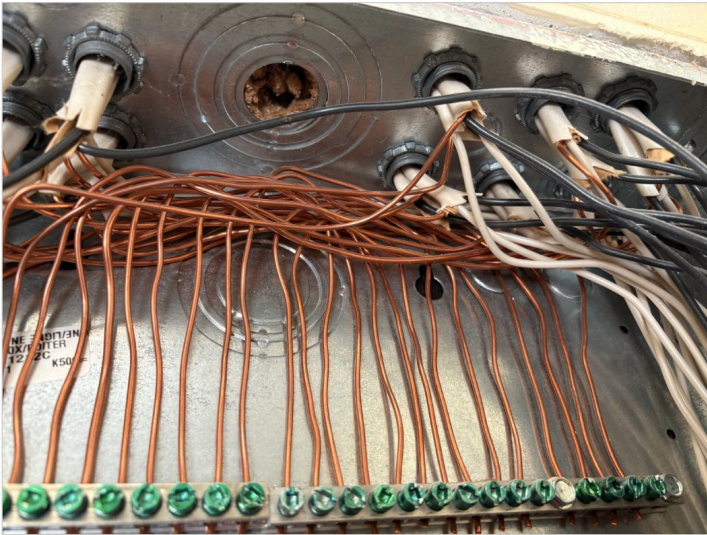
Hole in top of panel.

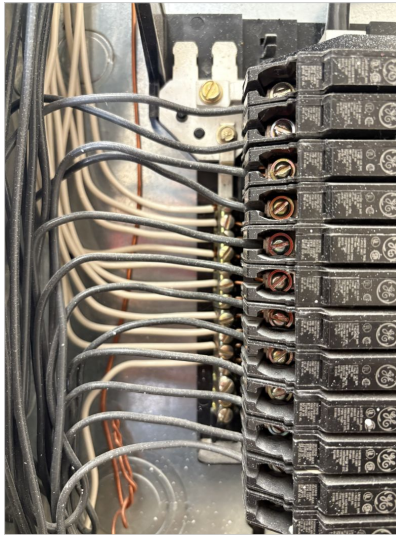
2.2. Observation: [Electrical branch circuits were observed to be inadequately labeled.](#)

Implication: [Inadequate labeling can lead to confusion and may create unsafe conditions during servicing or repairs.](#)

Circuit conductors were not labeled.

Recommendation: [Evaluation and proper labeling of the electrical panel circuits as needed by a qualified electrical contractor is recommended.](#)

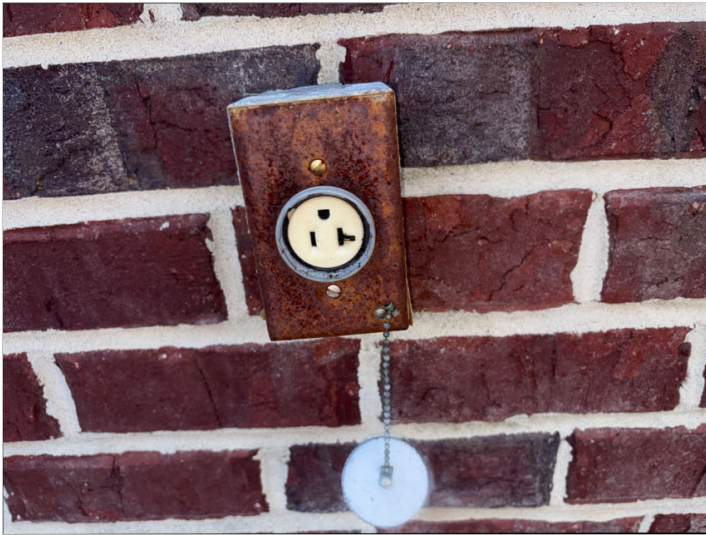
4.2. Observation: GFCI protection was not observed at receptacles in wet areas.

Implication: The absence of GFCI protection may increase the risk of electrical shock in areas where moisture is present.

Rear patio receptacle was not ground fault circuit interrupting type.

Recommendation: Evaluation and installation of GFCI protection as needed by a qualified electrical contractor is recommended.

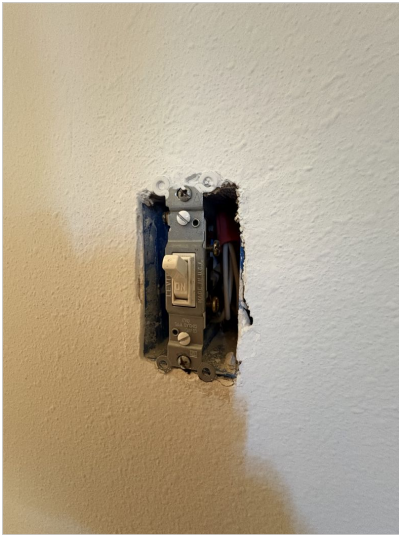
Upstairs closet light switch was missing a cover.

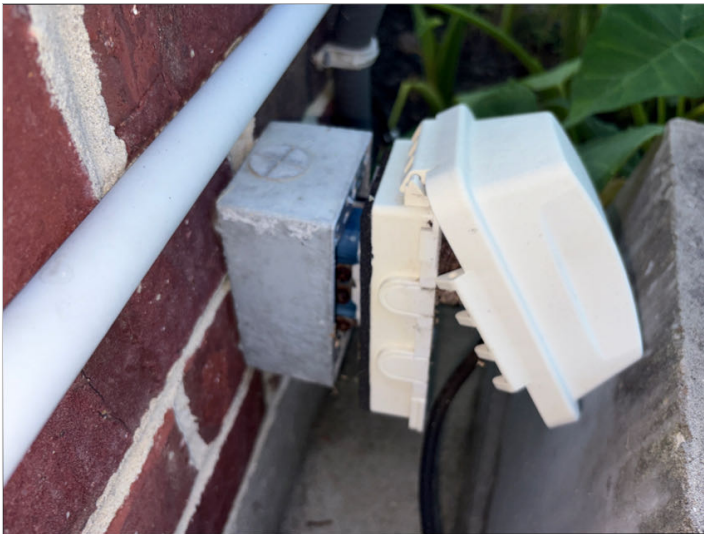
Sewer system blower receptacle not secured in electrical device box.

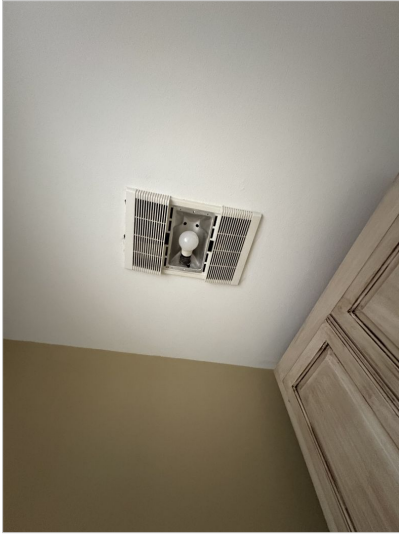
Upstairs bathroom lighting lens was missing.

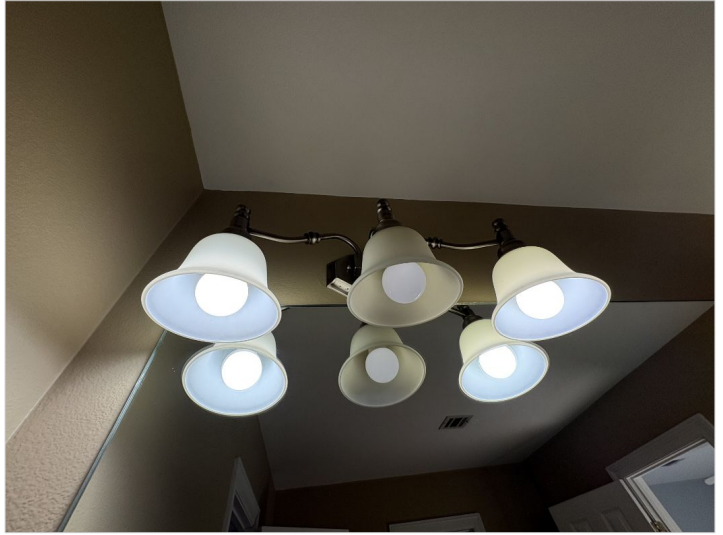
5.2. Observation: Some light fixtures were observed to not illuminate when the switches were operated.

Implication: Non-functioning fixtures may indicate a failure in the fixture or associated wiring and may require further evaluation.

Upstairs bathroom vanity light bulb did not illuminate.

Recommendation: Evaluation and repair of the affected fixtures and circuits as needed by a qualified electrical contractor is recommended.

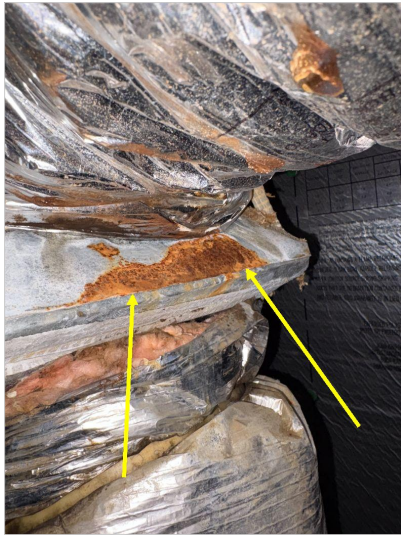
A branch air duct manifold showed signs of moisture damage.

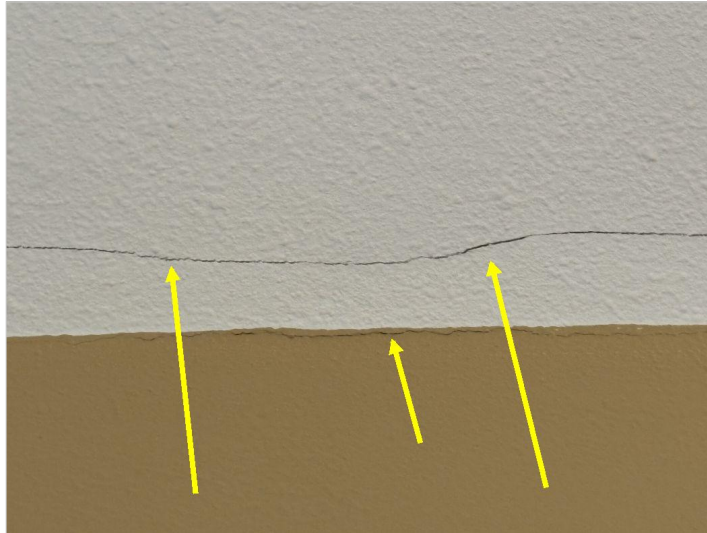
Ceiling crack in upstairs bedroom at end of hallway.

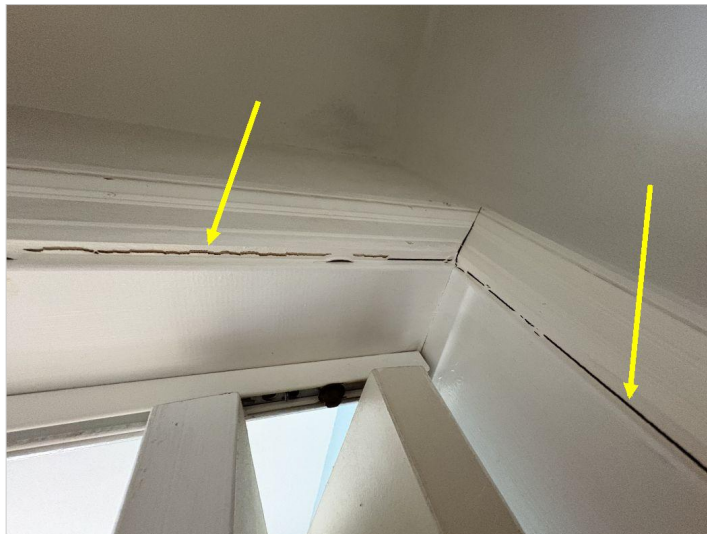
Upstairs closet door trim needs to be resealed.

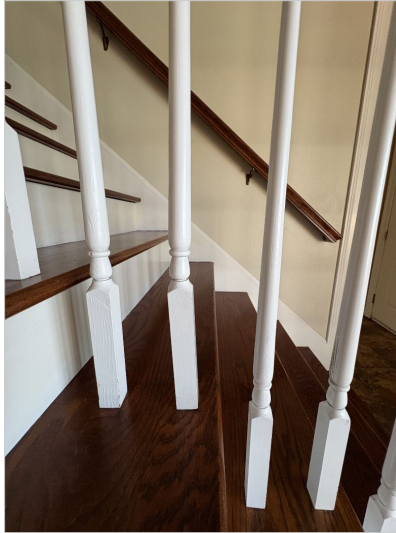
5.2. Observation: [A baluster at the handrail was observed to be damaged.](#)

Implication: [Damage to balusters may create excessive spacing and can present a safety concern.](#)

The stairs had a baluster that was broken.

Recommendation: [Repair or replacement of the damaged baluster as needed is recommended.](#)

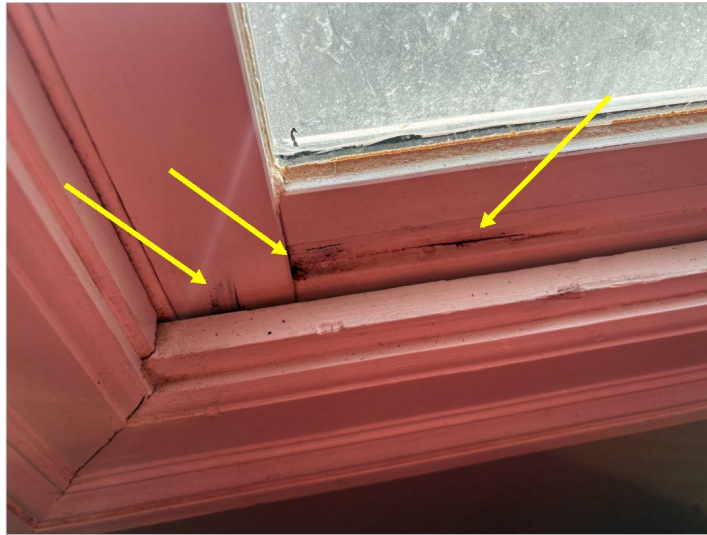
7.2. Observation: Window components were observed to be deteriorated from moisture. Some sills showed decay and separation, and some windows were difficult to operate or inoperable.

Implication: Moisture-related deterioration may indicate ongoing water intrusion and can affect the integrity of the window assembly and adjacent materials.

Upstairs bedroom window showed signs of moisture damage to wood sill. (Left-Front side of home)

Recommendation: Evaluation and repair or replacement of the affected windows as needed is recommended.

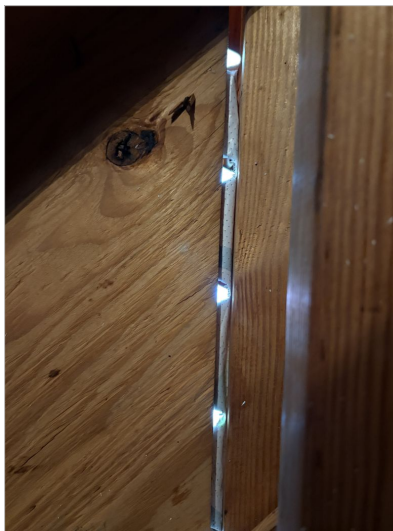
Open holes to outside where pest intrusion is possible.

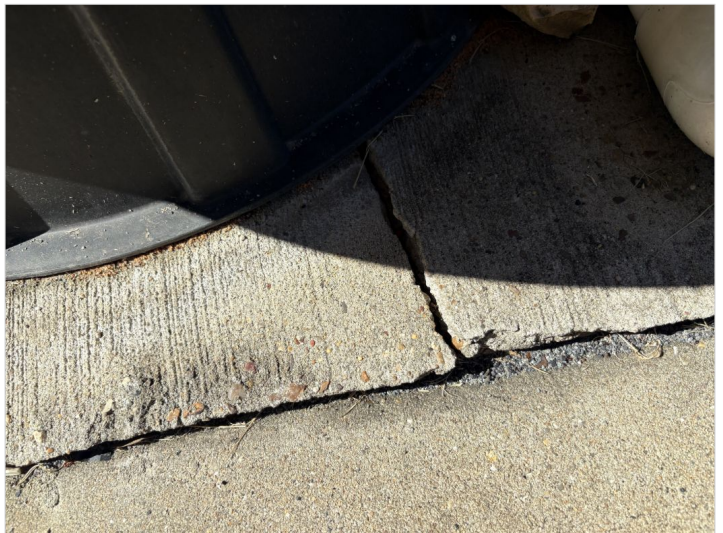
3.2. Observation: The concrete slab supporting the pool pump equipment was observed to be cracked.

Implication: Cracks in the slab may allow moisture intrusion and can lead to movement over time, which may affect the stability of the equipment.

Crack in pump equipment slab.

Recommendation: Evaluation and repair of the slab as needed to provide a stable base for the equipment is recommended.

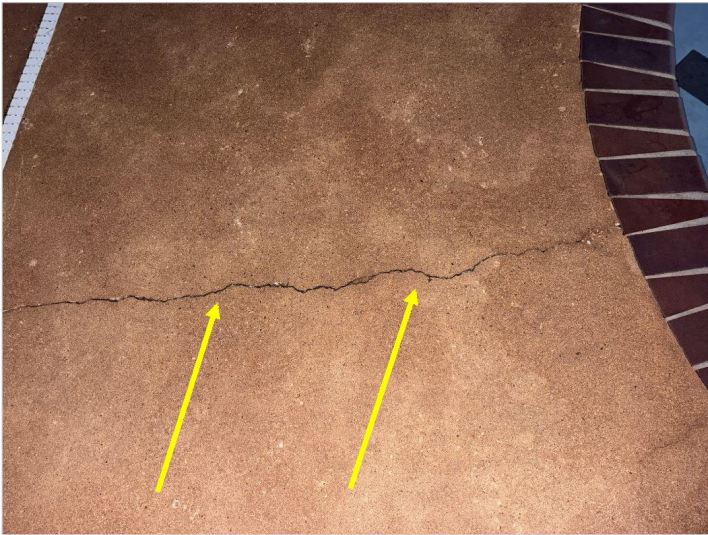
3.3. Observation: Significant cracks were present in the concrete near the pool edge.

Implication: Cracks in this area may allow water intrusion and can lead to movement of surrounding materials over time, which may affect adjacent structures.

Crack in perimeter slab.

Recommendation: Evaluation and repair of the cracks as needed to limit water intrusion and movement is recommended.

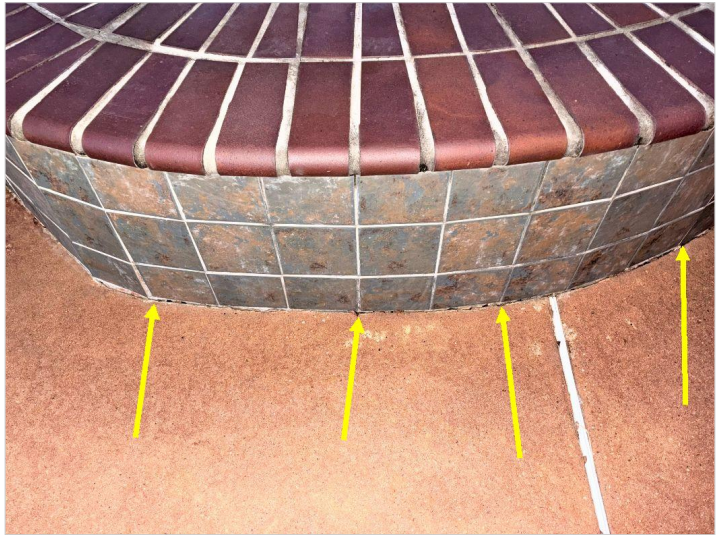
3.4. Observation: Sealant at the joint between the spa tile and the perimeter slab was observed to be deteriorated.

Implication: Deteriorated sealant may allow water intrusion and can contribute to deterioration or movement of adjacent materials over time.

Slab to hot-tub joint needs sealant to prevent water intrusion.

Recommendation: Removal and replacement of the deteriorated sealant as needed to limit water intrusion is recommended.

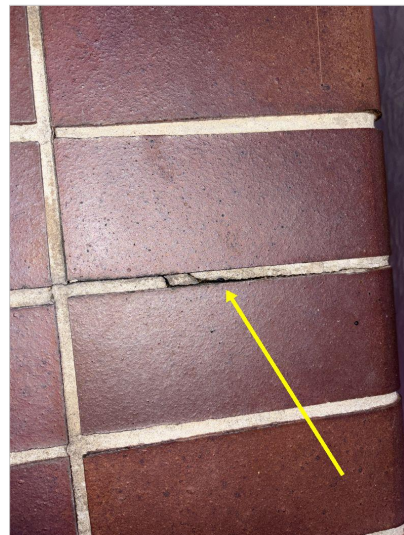
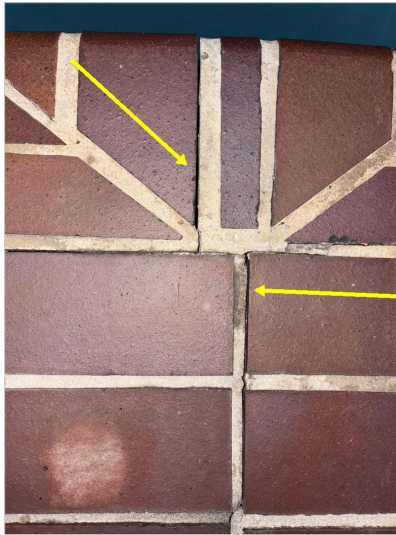
3.5. Observation: Mortar joints between coping tiles at the pool and spa edges were observed to be deteriorated in several areas.

Implication: Deteriorated mortar joints may allow water intrusion and can contribute to loosening or displacement of tiles over time.

Coping tiles need mortar sealant applied to prevent moisture intrusion that can cause settlement or heaving of perimeter slab.

Coping tiles needing sealant.

Recommendation: Repair of the mortar joints as needed to restore proper sealing and support is recommended.

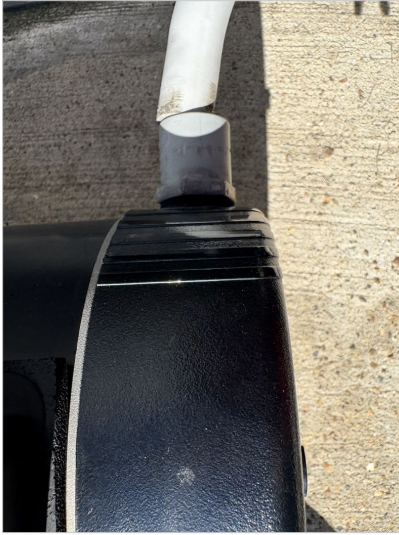
5.2. Observation: The electrical conduit connection at the pool pump motor was observed to be disconnected, exposing wiring at the motor.

Implication: Pool lights are inoperable. Exposed electrical wiring at the pump motor presents a shock hazard and can lead to equipment damage.

PVC conduit was disconnected from the adapter fitting at the pump.

Recommendation: Immediate repair of the electrical connection as needed to properly enclose and protect the wiring is recommended.

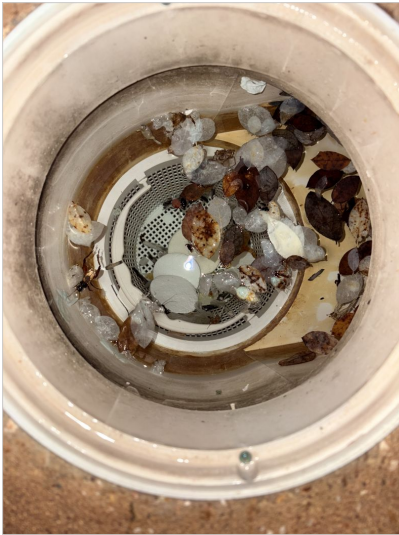
Skimmer is working properly but had debris.

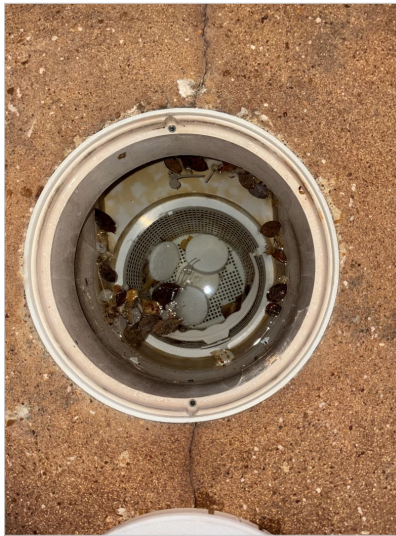
8.4. Observation: **Chemical tablets were observed inside the skimmers.**

Implication: **Placing tablets in skimmers can introduce highly concentrated chemicals into the system, which may damage equipment and affect water chemistry.**

Chemical tablets inside skimmer. The heater manufacturer recommends not to place any tablets inside the skimmers.

Recommendation: **Removal of tablets from the skimmers and use of an appropriate dispensing method as needed is recommended.**

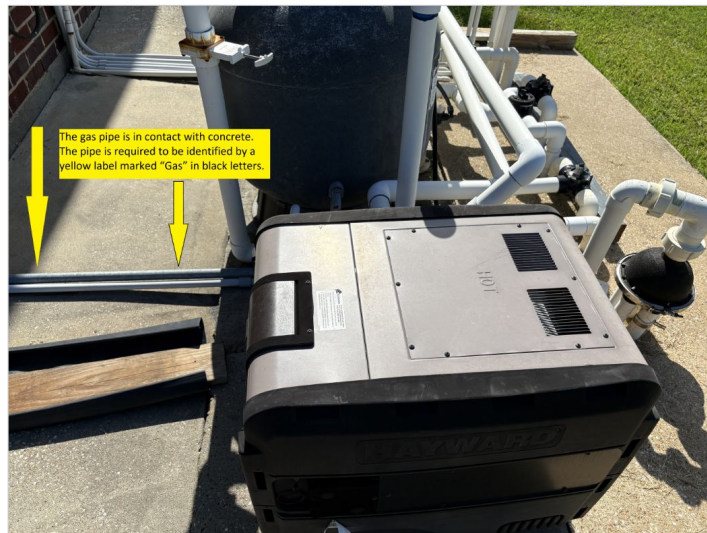
Implication: Unidentified gas piping can lead to confusion during service or maintenance and may increase the risk of improper handling.

Gas line was in contact with concrete and not labeled properly.

Recommendation: Identification of exposed gas piping as needed to clearly indicate its use is recommended.
