Repair Request List

Property Address:	Happy Ln, Lake Charles, Louisiana 70605
Date Time:	04/04/2022 01:00 PM
Client:	Donald Smith
Agent's:	Sam Rhodes
Inspector:	Jamie Beauxis LA#11291

Summary of Items

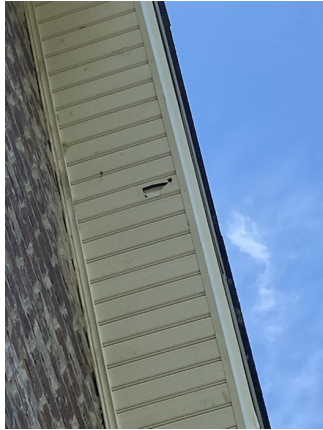
EXTERIOR TRIM - Eaves & Soffits

Page 13 Item: 2 - Repair: Small hole in eave soffit on right side of home. Recommend a qualified person repair.

Hole in soffit.

Option : Repair

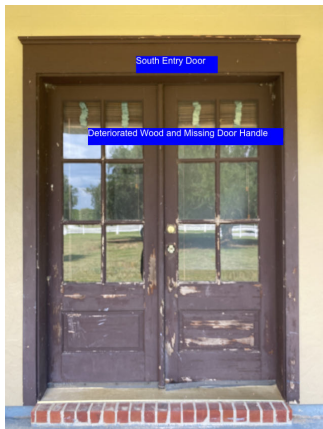
EXTERIOR DOORS - Condition

Page 14 Item: 2 - Repair: Light deterioration on door and trim surfaces. Recommend a qualified painter resurface to preserve wood.

South Entry Door: Coating deteriorated, missing handle.

Option : Repair

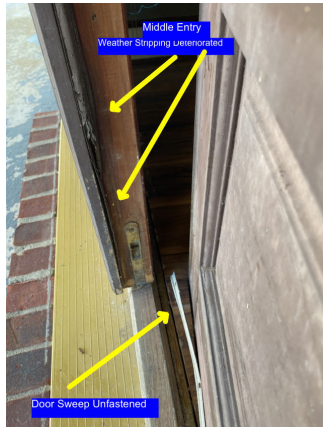
EXTERIOR DOORS - Condition

Page 14 Item: 2 - Repair: Weatherstrip on the middle entry door was damaged. Contact a qualified contractor.

Middle Entry Door weather stripping damage and unfastened door-sweep.

Option : Repair

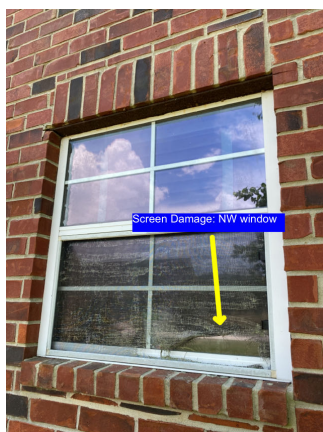
WINDOWS - Condition

Page 15 Item: 2 - Repair: North wall screen was damaged. Recommend a professional replace screen.

Northwest Window: Screen damage.

Option : Other , No Request - As Is

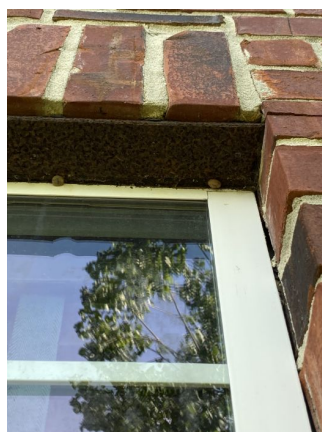
No seal. Lintel rusted.

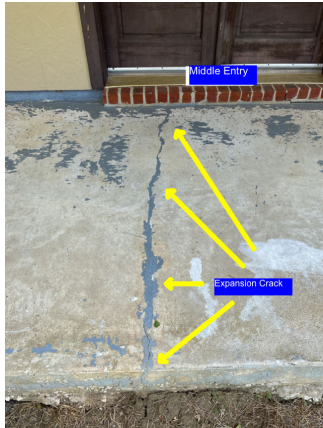
PATIOS - Front Patio

Page 16 Item: 1 - Repair: Concrete slab along front of home had cracking from possible settlement. Possible Cause: Lack of roof drainage. Contact a qualified contractor to evaluate and repair. Contact roof drainage contractor for gutter installations.

Front Patio: Hairline expansion crack near middle entry door.

Option : Fund for \$4000.00

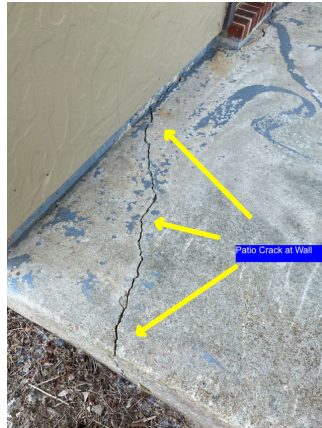
Front Patio: North end of lateral crack.

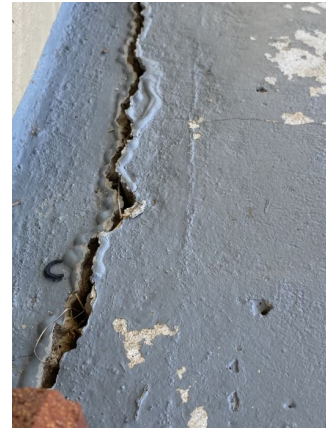
Crack along the wall.

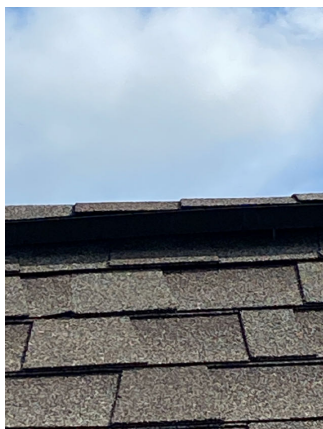
ROOF COVERING - Condition

Page 18 Item: 2 - Repair: Ridge vents not fastened. Recommend repair by qualified roofer.

Ridge vent should be fastened to prevent pest and moisture intrusion to attic.

Option : Repair

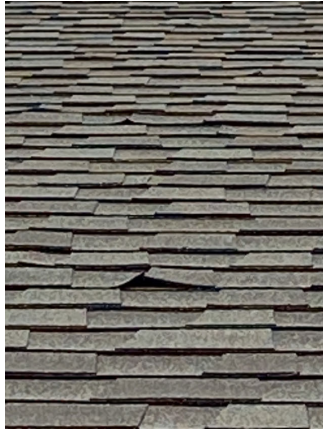
ROOF COVERING - Condition

Page 18 Item: 2 - Repair: A few shingles on the roof were not bonded during the inspection. Shingles should bond to provide wind resistance. Contact a qualified roofing contractor.

Shingles not bonded

Option : Repair

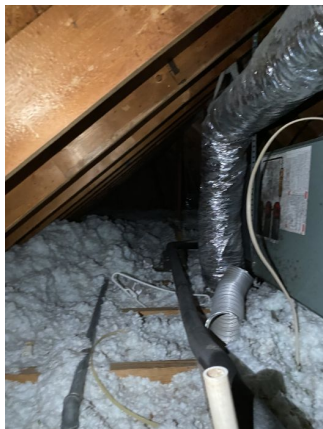
ATTIC - Condition

Page 20 Item: 2 - Repair: A light source should be installed in all attic spaces. Recommend installing attic lights by a qualified electrician.

No Work Platform, Limited
Access

Option : Fund for \$800.00

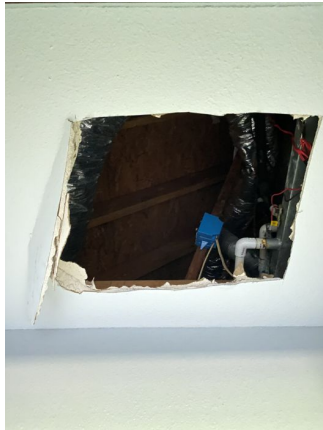
ATTIC - Condition

Page 20 Item: 2 - Repair: No access to attic above upstairs level where indoor furnace & evaporator unit is located. Access to ac units is required for maintenance. Recommend a qualified carpenter provide permanent access.

No permanent attic access.

Option : Fund for \$1200.00

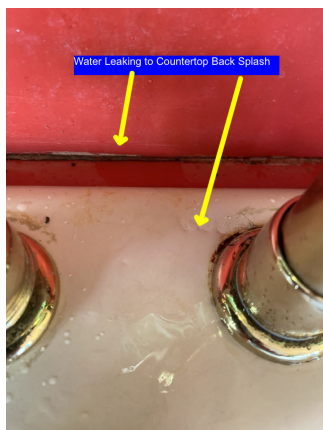
FIXTURES - Faucets

Page 22 Item: 1 - Location: Kitchen Repair: Faucet base leaked when operated. This leak is traveling to wall and down the back of cabinet causing wood damage and possible mold growth. Recommend replacing faucet by a qualified plumber.

Kitchen faucet base leaking.
Signs of water damage appeared
in cabinet below sink.

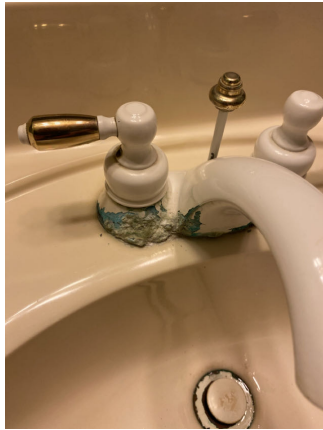
FIXTURES - Faucets

Page 22 Item: 1 - Location: Upstairs Bath Repair: Sink faucet leaked when cold water valve was turned on. Faucet had paint missing and metal corrosion causing faucet base to swell. Recommend replacing faucet by a qualified plumber.

Upstairs Bath faucet leaking and corroded.

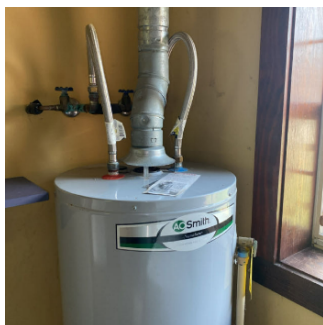
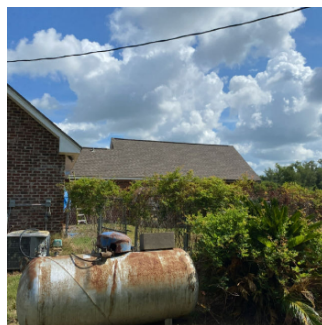
WATER HEATER - Condition

Page 23 Item: 2 - Operation: Not Operated. Propane Gas Unavailable

Option : Other , Request gas supplier service the propane tank and inspect for gas system leaks. Schedule return inspection for furnace and gas appliances.

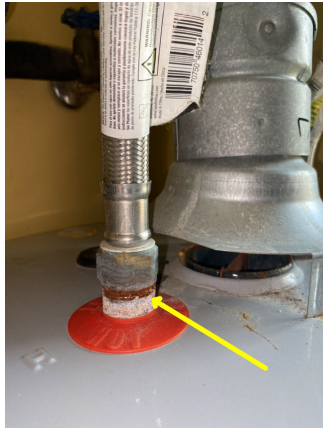
WATER HEATER - Condition

Page 23 Item: 2 - Repair: The hot water hose connection to the water heater had corrosion. Recommend repair by a qualified plumbing contractor to prevent future water leaks.

Water heater hot-side only
corrosion.

Option : Repair

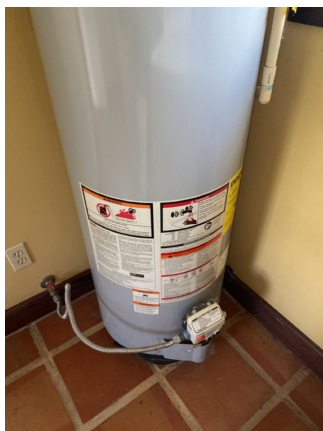
WATER HEATER - Drip Pan

Page 23 Item: 3 - Repair: No drip pan installed. Drip pan should be installed by a qualified plumbing contractor to prevent possible water damage to home.

Gas Water Heater - No drip pan
installed.

Option : Repair

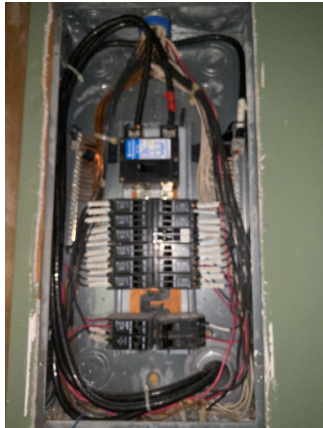
ELECTRICAL SYSTEM - Service Panel Condition

Page 25 Item: 3 - Note: Some Challenger panels and breakers have had recalls in the past. Information about this exact brand is unclear. Unable to determine if this model was recalled. Recommend a qualified electrician evaluate.

Electrical Panel was in satisfactory condition.

Option : Fund for \$4500.00

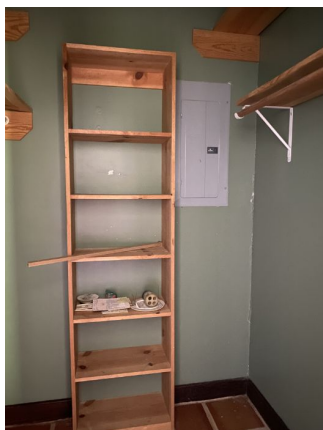
ELECTRICAL SYSTEM - Service Panel Condition

Page 25 Item: 3 - Repair: The service panel is located in the master bath closet and requires proper illumination. Recommend replacing bulb or further evaluation by a qualified electrician.

Insufficient clearance and next to clothes rack.

Option : Repair

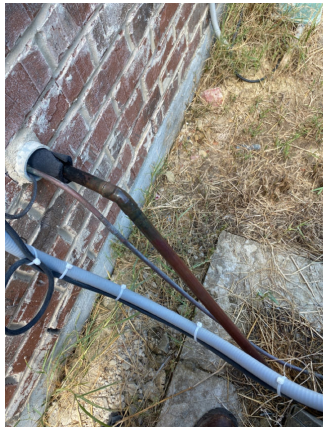
CENTRAL AIR CONDITIONER - AC Refrigerant Lines

Page 29 Item: 5 - Repair: Insulation on the compressor suction line was not installed. Cold lines missing insulation will generate copious amounts of water and lose efficiency. Recommend qualified contractor install proper density foam rated for refrigerant line use.

Condenser suction line not insulated.

Option : Other , No Request - As Is

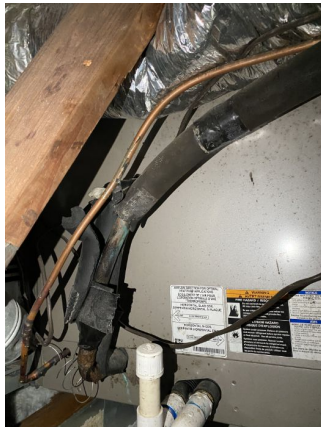
Missing Insulation

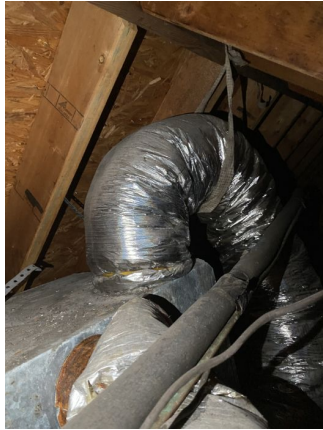
AIR DISTRIBUTION - Supply Air Ducts

Page 30 Item: 1 - Repair: Air-handler supply branch connector was rusted. Rusted ducts can eventually have air leaks resulting in wasted energy. Recommend qualified contractor repair to prevent further damage.

Air Duct Rust

Option : Replace

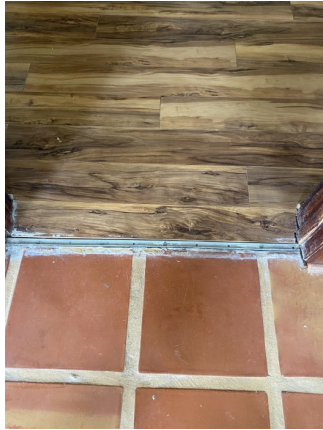
FLOORS - Condition

Page 32 Item: 2 - Location: Master Bed/Living Room Repair: Flooring transition-piece to living room missing. Contact a qualified handyman.

Transition strip is missing
between master bedroom and
living room.

Option : Repair

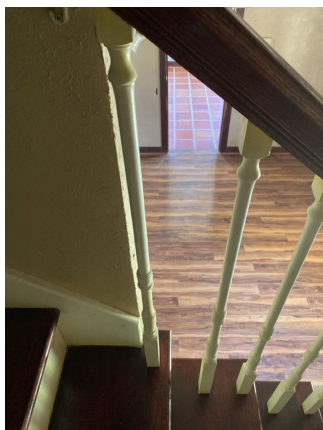
STAIRWAY to 2nd FLOOR - General Stairway Condition

Page 33 Item: 1 - Safety: The staircase handrail assembly had spaces between balusters greater than 4-inches. Recommend altering handrail to improve child safety. Contact a qualified carpenter.

Balusters were spaced more than
4".

Option : Other , No Request - As Is

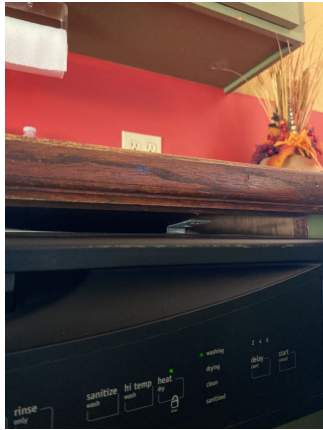
DISHWASHER - Condition and Operation

Page 36 Item: 2 - Repair: Dishwasher not mounted to cabinet. Recommend professional handyman.

Dishwasher needs to be properly supported to countertop.

Option : Other , No Request - As Is

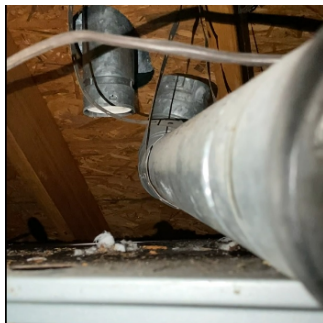
FURNACE - Condition - Furnace Condition

Safety: The disconnected exhaust flue was aimed at roof sheathing. This can cause a fire during furnace operation. Recommend repair by licensed HVAC contractor.

Option : Repair
