Advanced Home Inspections LLC

Property Inspection Report

Happy Ln, Lake Charles, LA 70605
Inspection prepared for: Donald Smith
Date of Inspection: 4/4/2022 Time: 01:00 PM
Age of Home: 10 Size: 1605

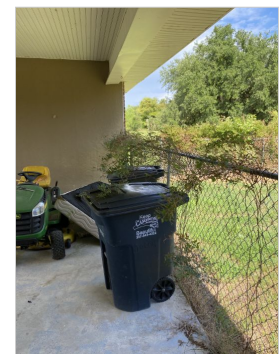
Page 14 Item: 2	Condition	<p>2.1. Repair: Cement board to brick veneer sealant was deteriorated. Recommend qualified handyman repair.</p> <p>2.2. Safety: Carport fence had poison ivy which entered into walking area. Contact a landscaping contractor for safe removal.</p> <p>2.3. Safety: No receptacles were GFCI protected. Recommend a qualified electrician update receptacles for safety.</p>
-----------------	-----------	---

Possible toxic vegetation extended into walking path outside exterior door.

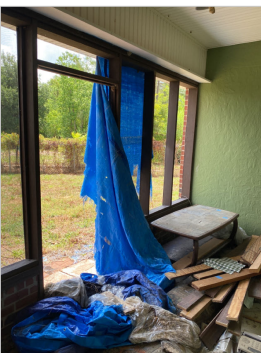
Back patio screens were missing. Excessive debris.

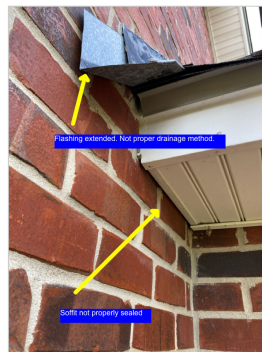
Soffit should be sealed to prevent pest intrusion.

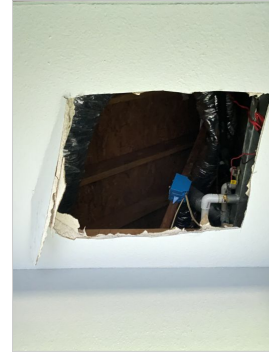
Page 19 Item: 2	Condition	<p>2.1. Repair: A light source should be installed in all attic spaces. Recommend installing attic lights by a qualified electrician.</p> <p>2.2. Repair: No access to attic above upstairs level where indoor furnace & evaporator unit is located. Access to ac units is required for maintenance. Recommend a qualified carpenter provide permanent access.</p>
-----------------	-----------	--

No permanent attic access.

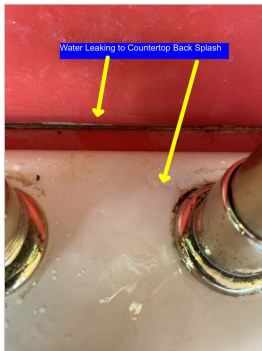
1.1. Location: Kitchen Repair: Faucet base leaked when operated. This leak is traveling to wall and down the back of cabinet causing wood damage and possible mold growth. Recommend replacing faucet by a qualified plumber.

Kitchen faucet base leaking. Signs of water damage appeared in cabinet below sink.

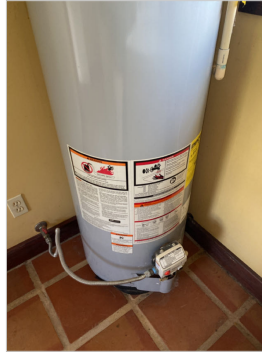
WATER HEATER Drip Pan

3.1. Repair: **No drip pan installed. Drip pan should be installed by a qualified plumbing contractor to prevent possible water damage to home.**

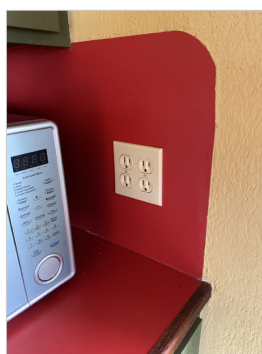
Kitchen receptacles are not GFCI protected.

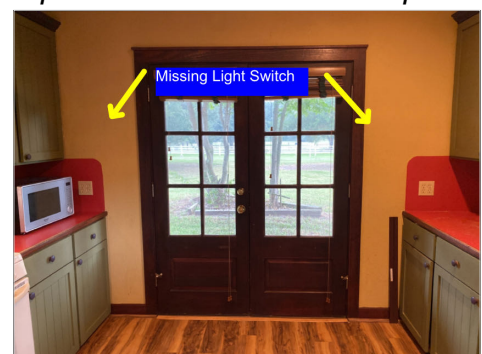
Kitchen light switch should be located at door entry.

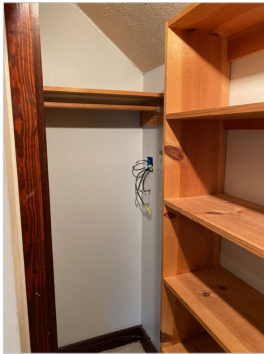
Wiring in upstairs bedroom-2 closet needs to be covered properly.

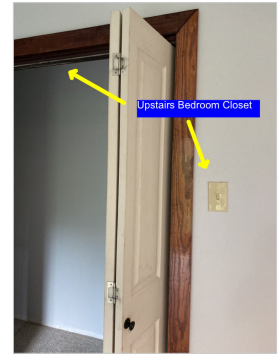
Upstairs Bedroom Closet: Light not functioning.

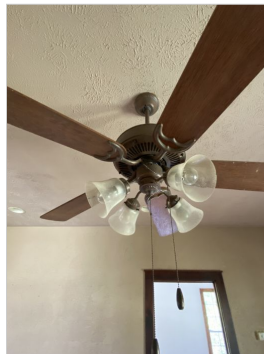
Living room ceiling fan wobbles.

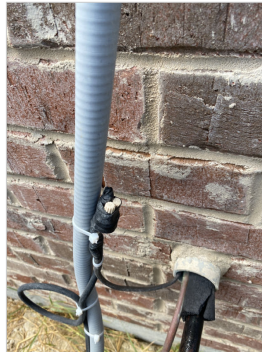
Exposed wiring connection for thermostat.

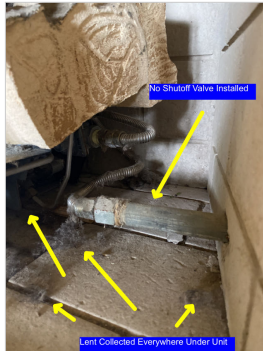
No gas shutoff valve installed.
