ADVANCED HOME INSPECTIONS

Property Inspection Report

Date of Inspection: 5/5/2026

Inspector: Jamie Beauxis LA#11291

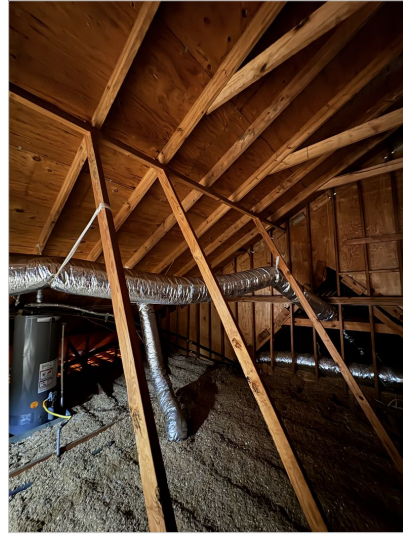
3.2. Observation: [A purlin support board in the attic was observed to be warped.](#)

Implication: [Warped supports can reduce the structural integrity of the roof system by failing to provide uniform support to the rafters. Proper support requires these members to be straight and, for spans exceeding 8 feet, reinforced with T-back bracing to prevent future bowing or failure.](#)

Support boards not strengthened by T-Back board.

Recommendation: [We recommend a qualified carpenter evaluate the warped board and replace it with a straight, properly braced support to maximize roof stability.](#)

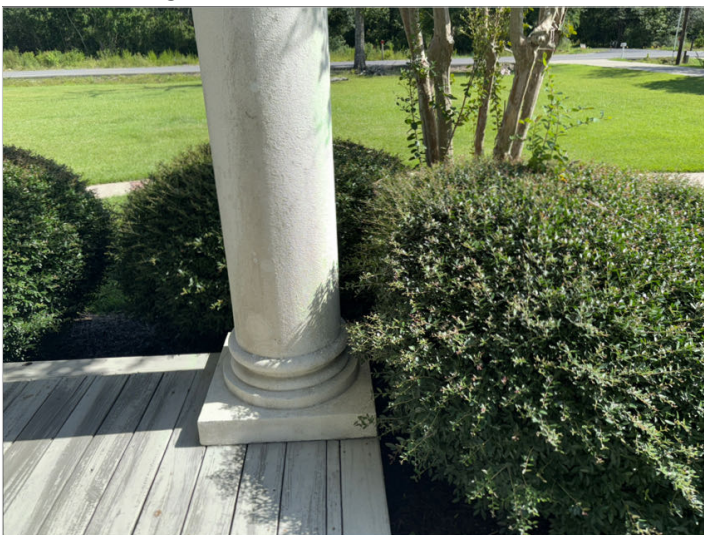
12.2. Observation: Landscaping shrubs were observed to be overgrown against the foundation and front columns.

Implication: Vegetation in contact with the structure can trap moisture against exterior surfaces and may facilitate pest access.

Vegetation in contact with deck.

Recommendation: Trimming of vegetation to provide clearance from the structure is recommended.

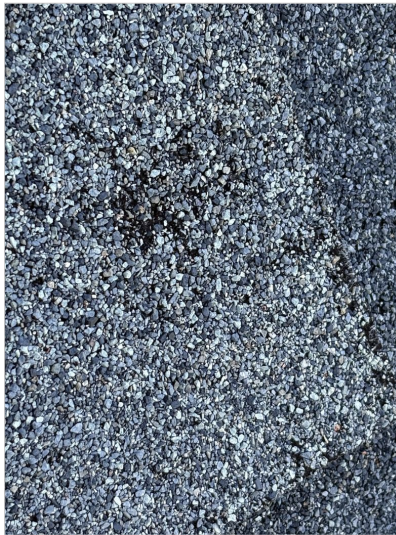
Some shingle granules were missing.

Area with granules removed from shingles.

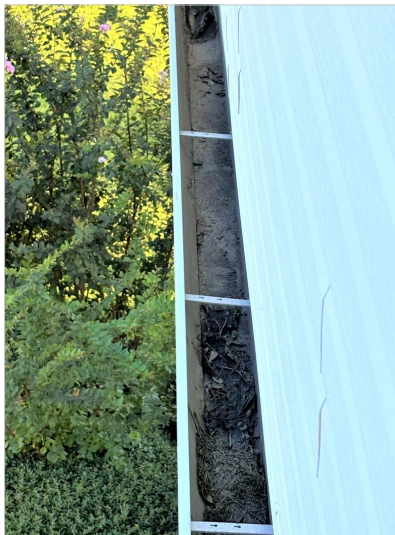
Debris was inside gutter located at rear-right side of home above patio.

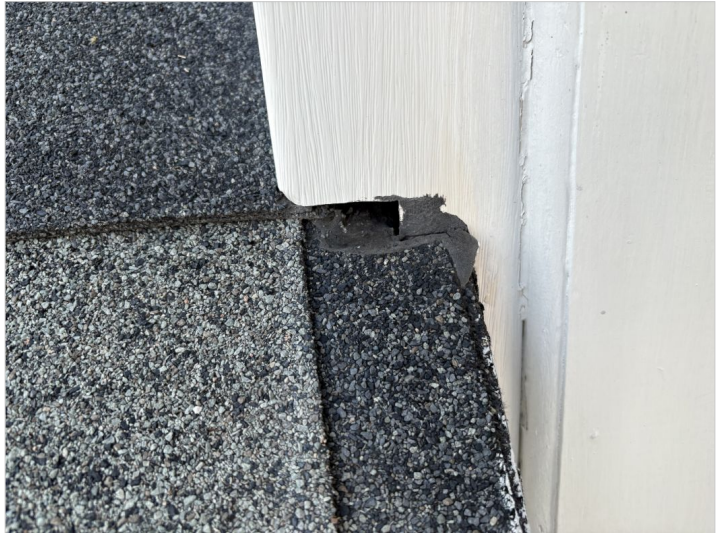
Close-Up of insufficient flashing and sealant located at end of balcony.

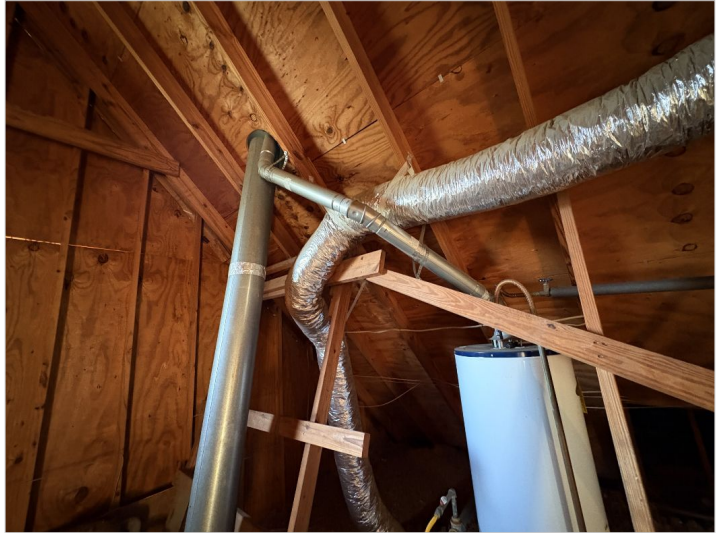
Water heater flue in contact with combustible material. A better option would be for the flue to go straight up to penetrate the roof.

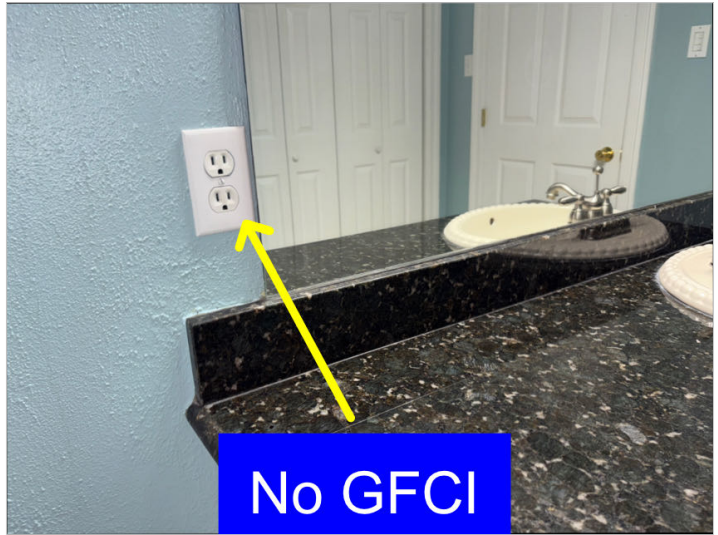
No GFCI in upstairs bathroom.

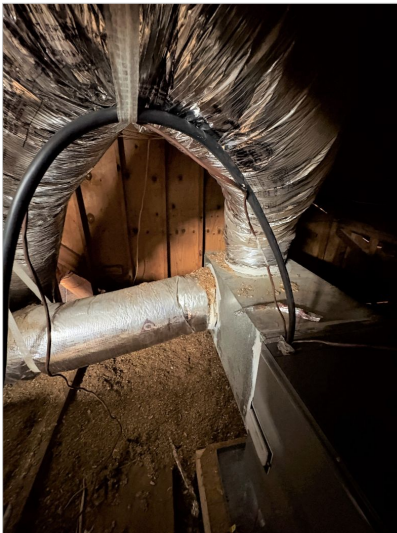
Electrical cable was not properly supported.

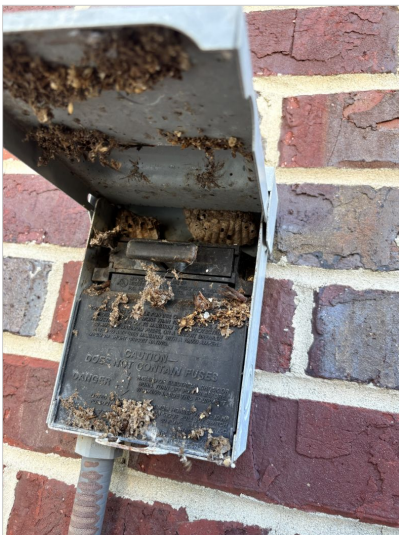
Pest intrusion into HVAC 1 disconnect.

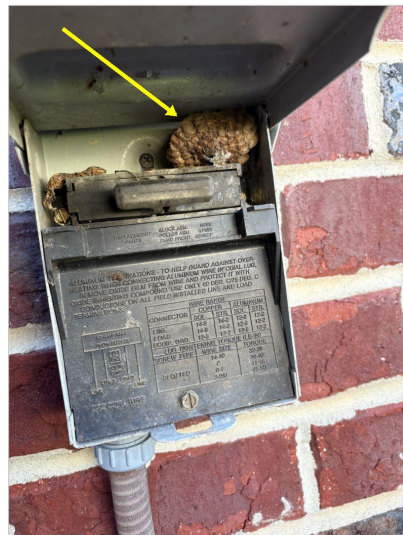
Pest intrusion into HVAC 2 disconnect.

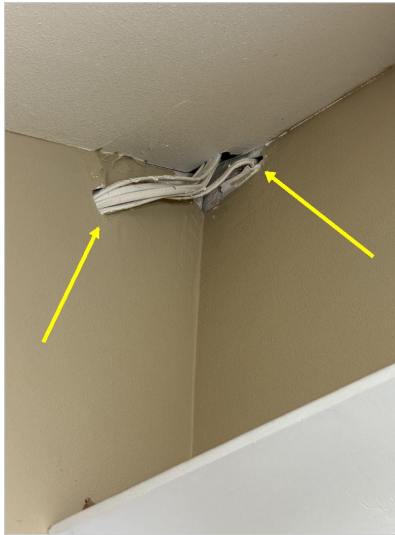
Electrical cables exposed.

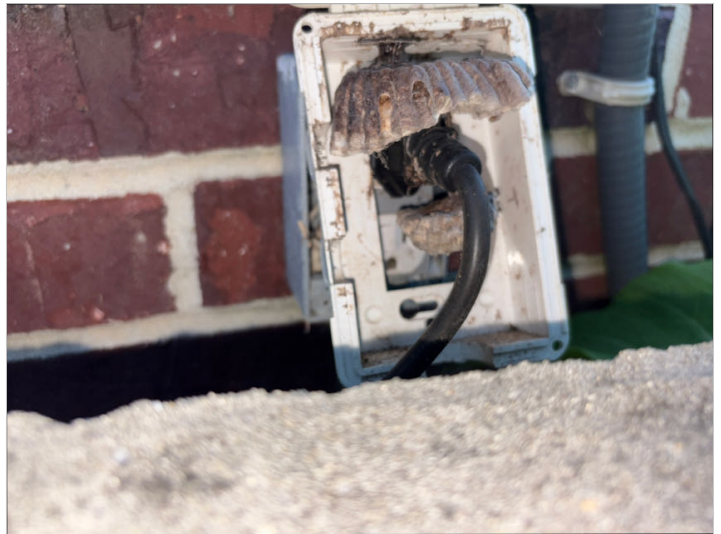
Sewer system blower receptacle not secured in electrical device box.

Same receptacle for sewer blower.

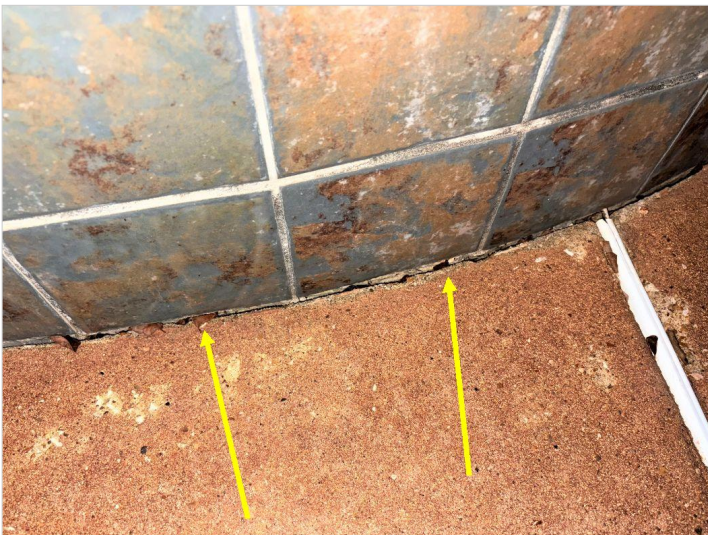
Slab to hot-tub joint needs sealant to prevent water intrusion.

Close-up of hot tub to slab joint needing sealant.
