Advanced Home Inspections LLC

Property Inspection Report

Happy Ln, Lake Charles, LA 70605
Inspection prepared for: Donald Smith
Date of Inspection: 4/4/2022 Time: 01:00 PM
Age of Home: 10 Size: 1605

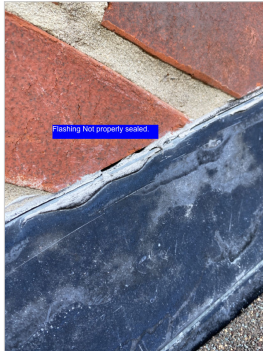
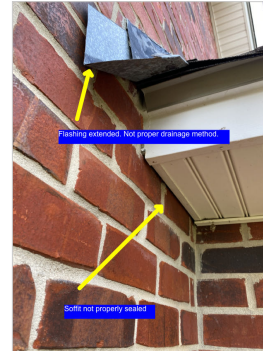
Page 18 Item: 3	Flashing	<p>3.1. Repair: Northwest of carport. Sidewall flashing sealant was deteriorated and cracked. Recommend a qualified contractor replace sealant.</p> <p>3.2. Repair: Location: Back of Shop. Drip ledge not fastened well at joints. Contact a qualified roofer.</p>
Page 18 Item: 4	Roof Penetrated Vents	<p>4.2. Repair: Shingles around vent pipe jacks were not installed neatly. Recommend repair if needed by qualified roofing contractor.</p>

Carport wall flashing sealant should be removed and replaced with fresh sealant. Soffit should be sealed to prevent pest intrusion.

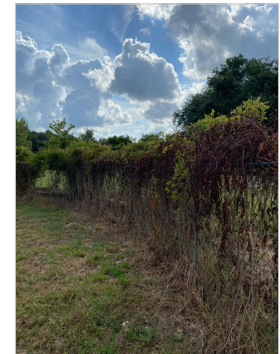
GROUNDS		
Page 11 Item: 2	Property Lot Condition	<p>2.1. Safety: Backyard fence was overburdened with poison ivy. Contact with poison ivy may cause allergic reactions, including severe rashes and itching. Recommend removal by a qualified landscaping contractor for safe and proper removal.</p> <p>2.2. Repair: Fence gate and related components were damaged. Recommend repair by a qualified fence contractor.</p> <p>2.3. Repair: Vegetation was contacting roofing covering. Potential damage to shingles is likely. Recommend a professional remove limb or entire tree.</p>
Page 11 Item: 3	Exterior Lighting	<p>3.1. Safety: Front patio light fixtures were inoperable and middle fixture was missing. Contact a qualified electrical contractor.</p>
STRUCTURAL SYSTEMS		
Page 12 Item: 2	Floor	<p>Some cracking on front patio. Recommend a licensed contractor evaluate causes.</p>
EXTERIOR WALLS		
Page 12 Item: 2	Condition	<p>2.1. Repair: Few deficiencies were observed. A small amount of mortar was missing on left side of home. Recommend patching hole to prevent moisture and pest intrusion.</p>

Possible toxic vegetation on fence.

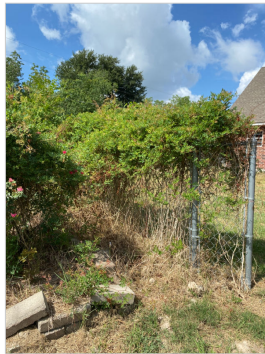
Possible toxic vegetation behind shop

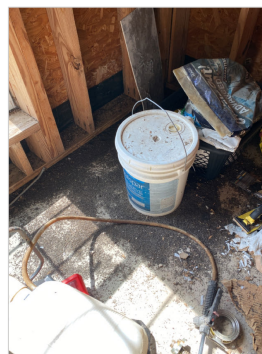
Debris in attached shop.

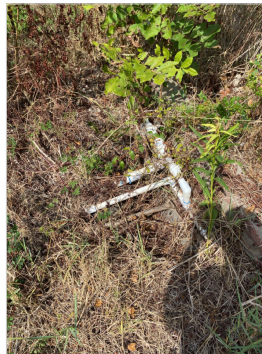
Water source piping for water well behind fence. Unable to determine water source due to vegetation overgrowth.

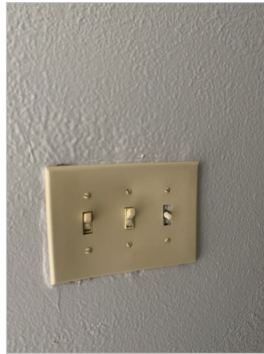
Unable to determine what the two left switches operate.

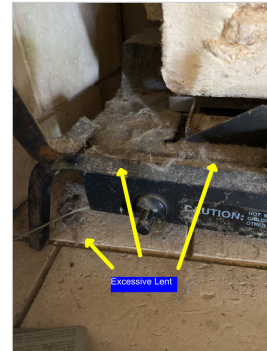
Excessive Lent

2.1. Repair: Excessive lent was on bottom side of heater. Recommend serviced by professional.

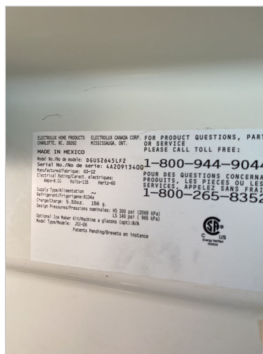
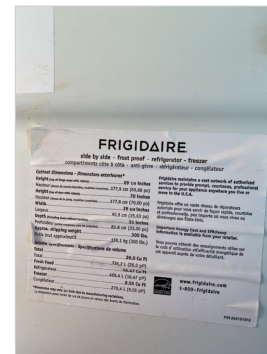
Refrigerator Data

Manufacturer: Frigidaire Type: Side By Side Freezer/Ref, Frost Free

Model: DGUS2645LF2 SN: 4A20913400 Capacity: 26 cu ft

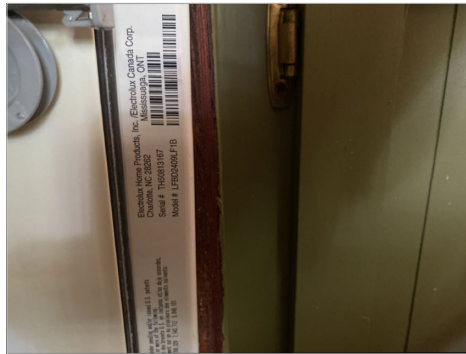
Dishwasher Data

Model: [LFBD2409LF1B](#)

SN: [TH50813167](#)

2.2. Repair: Dishwasher not mounted to cabinet. Recommend professional handyman.
