ADVANCED HOME INSPECTIONS

Property Inspection Report

Date of Inspection: 5/5/2026

Inspector: Jamie Beauxis LA#11291

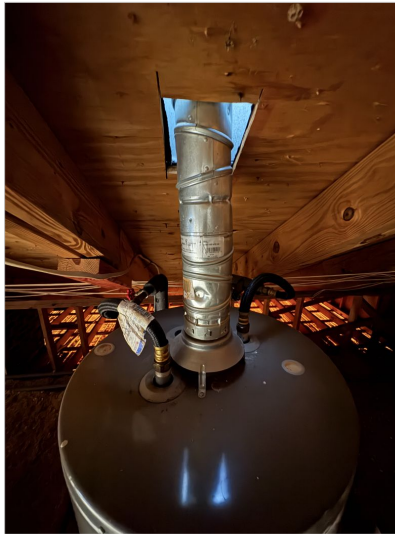
Upper attic water flue is within contact of wood sheathing. Should be minimum of 1 inch clearance from combustible materials.

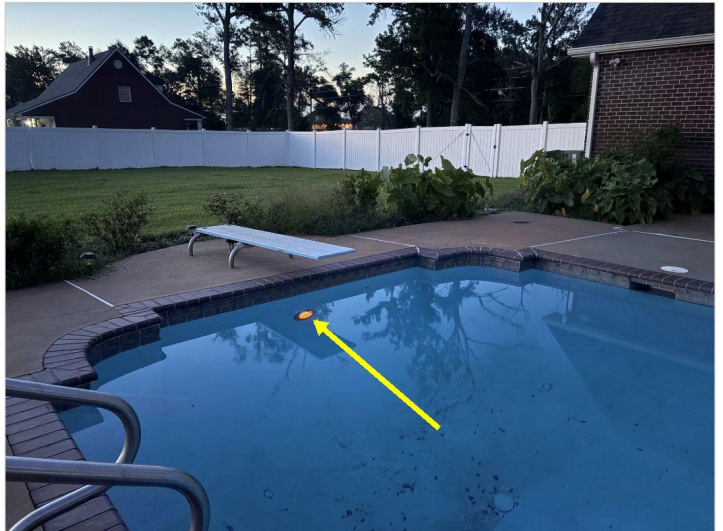
7.4. Note: **Pool light cycled on and off. The cause was unknown.**

Pool light below diving board.
